WELLS Counter Point

Volume 3 Issue 1, January 1999

Understanding Hall Effect Sensors

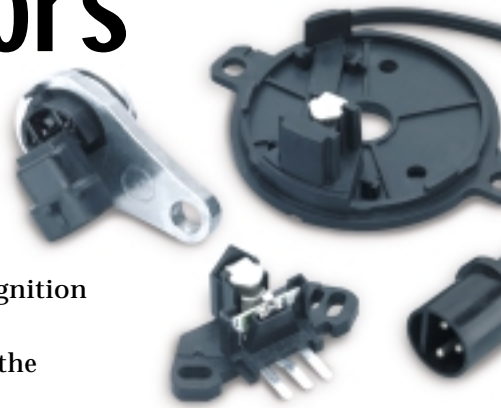
Hall Effect Sensors are used in many ignition

system distributors to trigger the primary circuit (fire the coil) and to monitor engine rpm.

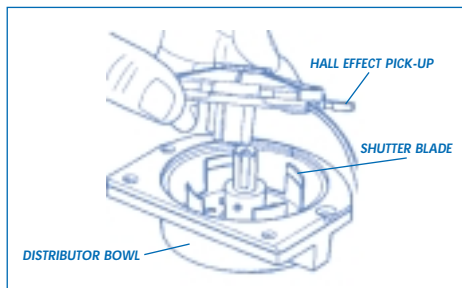
Hall Effect Sensors are sometimes referred to as "switches" rather than sensors because of the on-off "digital" voltage signal they produce. Unlike magnetic sensors that produce an alternating current (AC) signal which varies in voltage with speed, Hall Effect Sensors produce a constant voltage signal that can change abruptly from maximum voltage to nearly zero and back again regardless of engine speed. This produces a square wave output signal that can be easily used by the onboard computer for timing purposes.

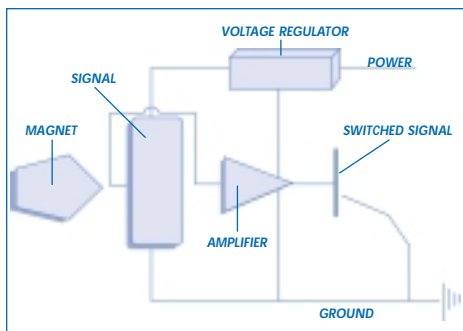
back to 1879 when Edwin H. Hall, an American scientist, discovered a new electrical phenomenon. When he applied an electric current to a piece of metal inserted between two magnets, it created a secondary voltage in the metal at a right angle to the applied voltage. The discovery didn't have much practical use at the time, but it turned out to be just the thing that future engineers would need to create a switching device capable of producing an efficient on-off square-wave voltage signal. The Hall Effect was adapted so the voltage change would occur in a silicone chip placed at a right angle to a magnetic field.

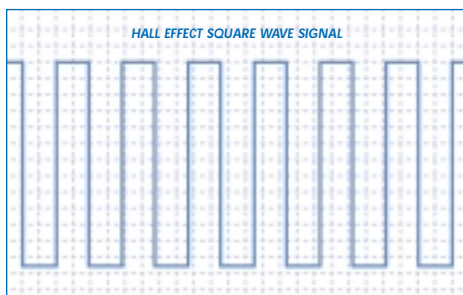
When a metal blade passes through the air gap between the magnetic field and silicon chip, it blocks the magnetic field and causes the chip's output voltage to suddenly drop to zero. With additional circuitry, the sensor can be made to do just the opposite: to produce a voltage signal when the blade enters the magnetic field. Additional circuitry regulates the supply voltage to the chip and amplifies its voltage output. In an automotive ignition system, shutter blades are mounted on the distributor shaft, rotor, crankshaft pulley or cam gear so the sensor can generate a trigger and/or position signal as the crankshaft rotates. In some applications, a notch in a pulley, a gear tooth or even a rotating magnetic button serves the same purpose as the shutter blade to disrupt the sensor's magnetic window and trip the switch.

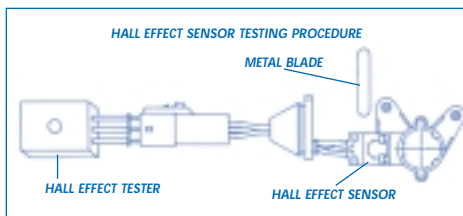
Sensor problems can be caused by wiring faults, loose or corroded connectors, or arcing that damages the internal electronic circuitry. There are several ways to troubleshoot Hall Effect Sensors. One is to use a self-powered "indicator light" type of Hall Effect Tester that flashes when the sensor's output signal changes. If the sensor is being tested on the vehicle, simply plug the tester into the sensor, then crank the engine and observe the indicator light. It should wink on and off while the engine is cranking. If the sensor is being tested off the vehicle, plug the tester into the sensor connector and observe the indicator light. It should remain on steadily. Then insert a metal blade into the sensor's magnetic window (air gap). The indicator should go off while the blade is in the window, then wink back on when the blade is removed. No change would indicate a faulty sensor.

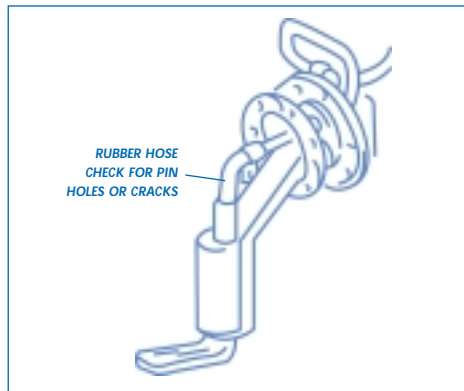
Whenever the fuel pump is replaced, be sure you check the fuel pump hose for signs of cracking or pinholes. Inside the fuel tank on these vehicles, a rubber hose serves as the fuel passage between the fuel pump motor and the fuel pump assembly mounting plate. If this hose becomes cracked or develops pinholes, low fuel pressure will result. Maximum fuel pressure may drop to the 20-25 psi range.

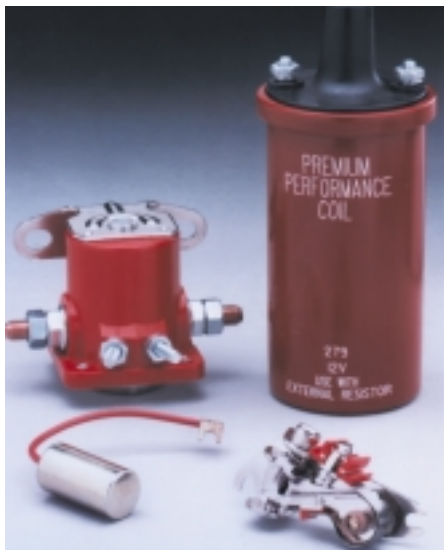
WELLS Manufacturing Corp. has added three new categories to its premium Professional Gold line of distributor caps and rotors: oil-filled coils, starter solenoids and tune-up kits.

- 1 **Oil-Filled Coils**
 - increased number of wire windings for greater output voltage
 - heavy-duty insulator for longer life
 - double outer laminations for a stronger magnetic field
- 2 **Starter Solenoids**
 - high-temperature insulated wire for better heat resistance
 - nickel-plated mounting bracket for better ground
 - increased contact area on studs for higher electrical current capacity and longer life
 - heavy-duty gasket to seal out moisture
- 3 **Tune-Up Kits**
 - nickel-plated point set with copper strip for higher conductivity
 - double-plated condenser with precision windings, brass terminals and insulated multi-strand copper wire for optimum energy
