Austin Healey BN1/2 Quick Reference Concours Chart of Production Changes by Chassis, Engine and Body Numbers *(Compiled by Curt Arndt - 01/14/2019)*

This list denotes changes listed by either chassis, engine, body number and approximate date. **This chart is designed as a quick reference guide with photos to help the owner and others identify the various changes throughout 100 production.** *These are just some of the more obvious or visible changes, and are typical of the questions owners ask about their cars. A more detailed and complete list can be found in the Concours Guidelines and other publications such as the Clausager book.*

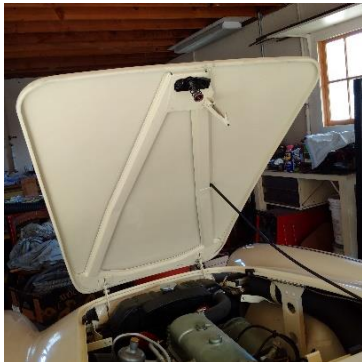
Body no. 724 (c1496XX) Nov '53 to body no. 877 (c149XXX) Nov./Dec. '53 – Sometime during this period, a side to side cross brace was added to the aluminum bonnet frame for strength and stiffening. This brace is a rectangular “U” shaped channel attached to the underside of the “V” brace with four truss head sheet metal screws. The exact changeover body no. is unknown and may be before no. 877.

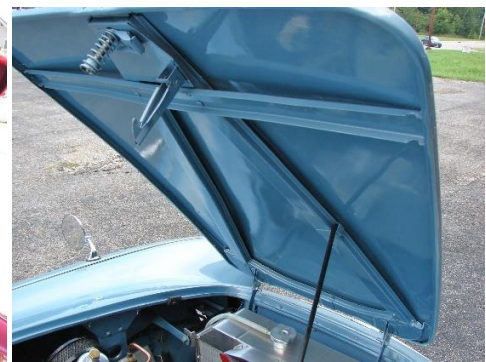
All cars, body no. 877 and after to no. 3396

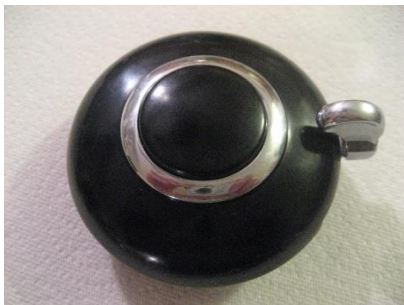
Body no. 1001 (c149930) Dec '53 – Adjustable steering column discontinued, driver's seat now on slides. The smaller hub of the non-adjustable steering wheel necessitated a decrease of the width of the aperture in the fascia (dash). The chromed turn signal lever which denoted an adjustable steering column was replaced with a black “beak” type which denoted a non-adjustable steering column. Austin Service Journal dated 10 May 1954 addresses this change.

BN1 adjustable.

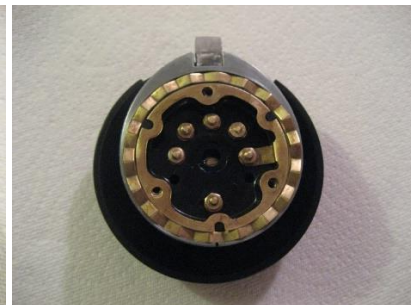
Early adjustable, back side.

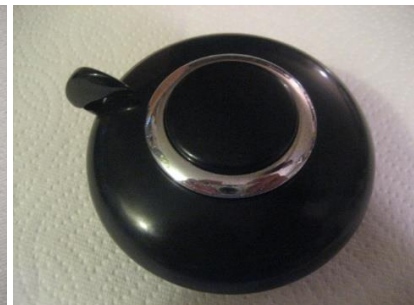
BN1/2 non-adjustable.

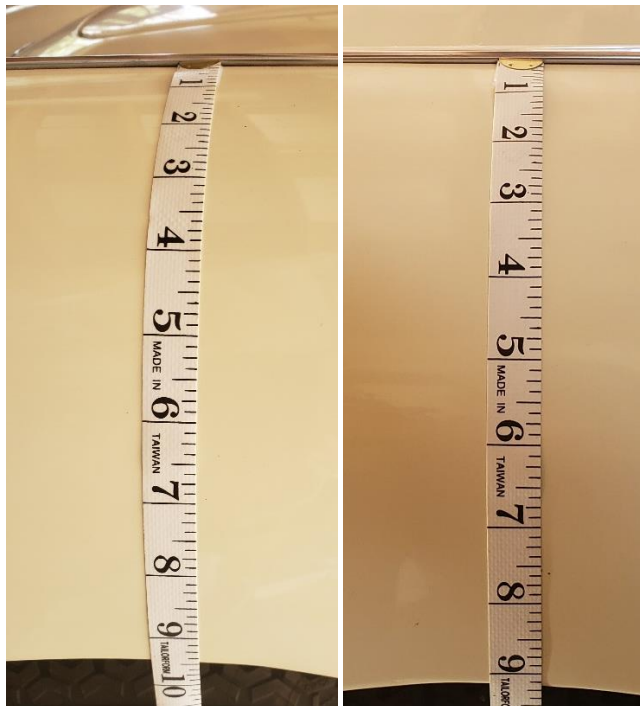
Body no. 1001 (c149930) Dec '53 – Front wings with 3/16" to 1/2" higher wheel cutout. 9" from beading to top of the wheel arch. *Therefore, most early BN1s before body no. 1000 had front wings whose wheel cutout from beading to top of the wheel arch was approximately 9-3/16" to 9-1/2".*

BN1 left wing 9-1/2"
No.724 Nov. '53

BN1 right wing 9-3/16"

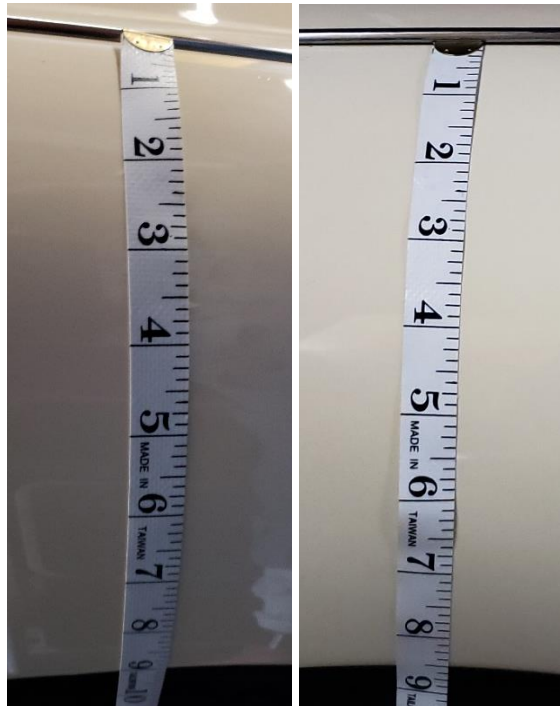
BN1 right wing 9"
No. 7197 Jan. '55

NOS BN1 left wing, 8-1/2"

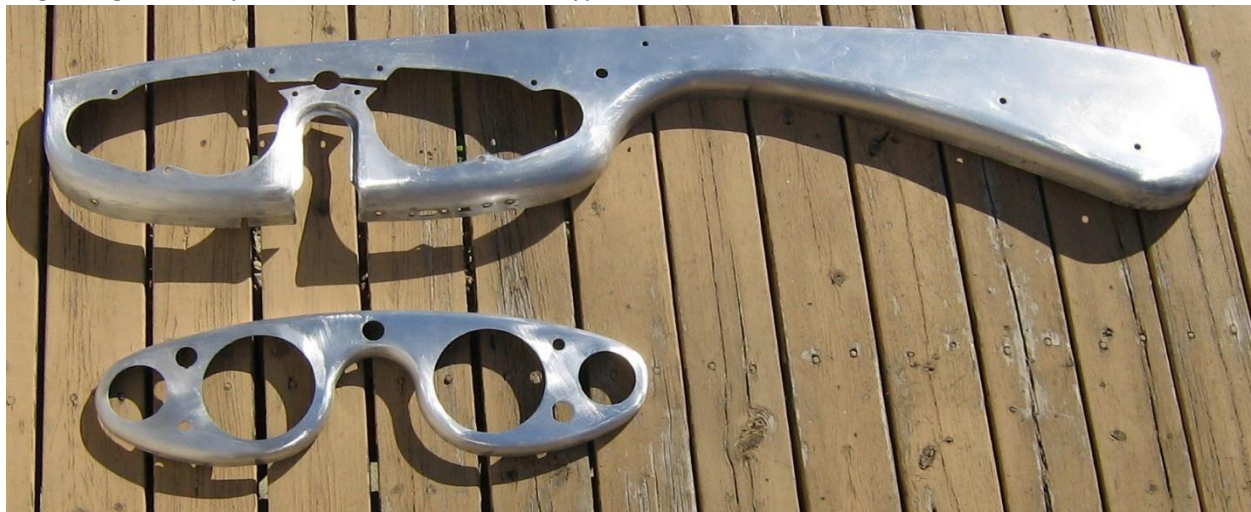
Body no. 1855 (c151795) Feb '54 – Fascia and instrument panel changed from two piece to one piece. Regarding the two piece dash, there were two types and two removable instrument cluster sections.

This type pictured above is the later type for cars with non-adjustable steering. Note the flange extension in the "U" shaped channel for the steering column. This type had the rounded tabs on the back, versus the square tabs.

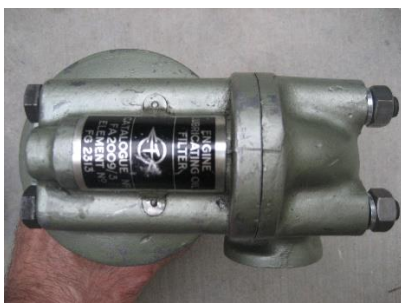
Early Tecalemit

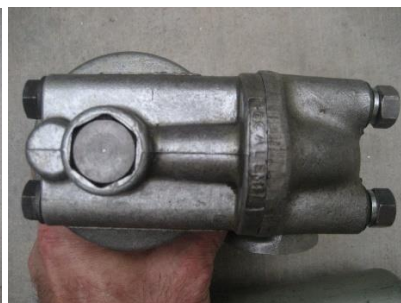
Late Tecalemit.

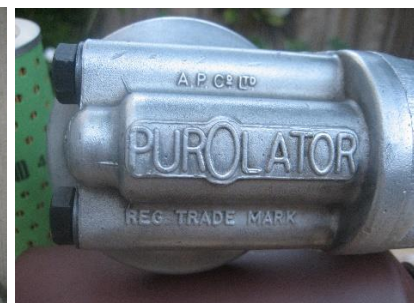
Purolator filter.

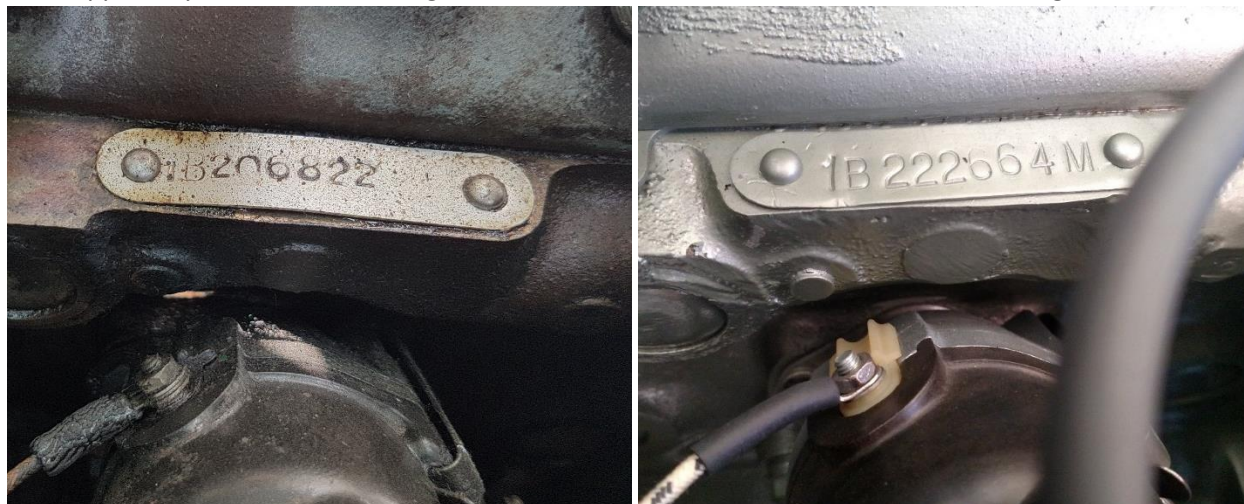
Engine no. 213XXX May '54 – An “M” suffix was added to the engine number to indicate that the engine was supplied by Morris. The last engines without the M suffix were in the 1B208XXX range.

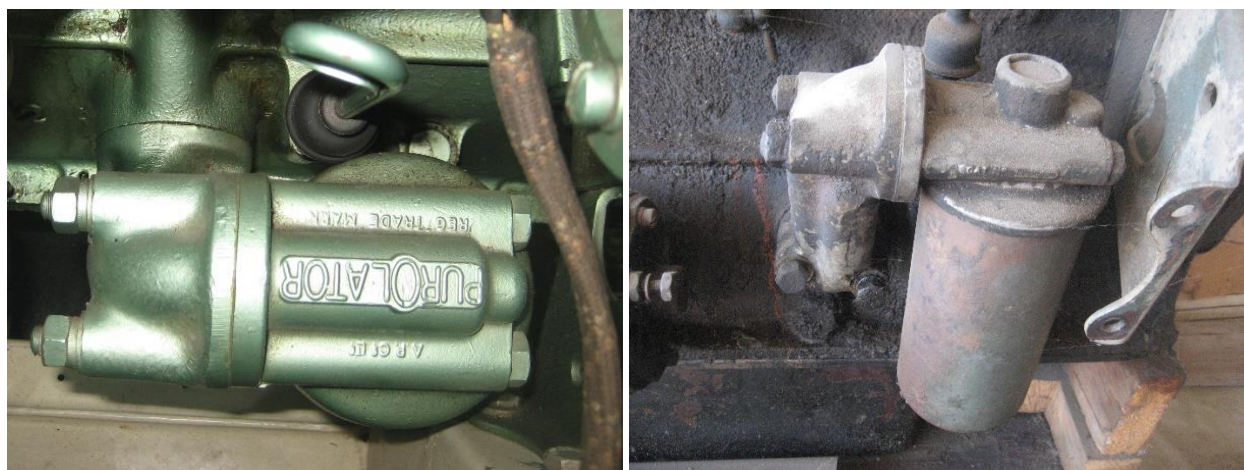
Engine no. 213325 May '54 – Modified adapter to oil filter: filter now vertical rather than angled, for improved clearance to engine mounting. Used on both the early Tecalemit and Purolator oil filters. *Several of the original oil filter adapters I have seen have been repaired by TIG welding which supports that this was a very necessary change (The oil filter contacting the engine mount, cracking the adapter).*

A Purolator and a “late” Tecalemit filter assemblies oriented vertically.

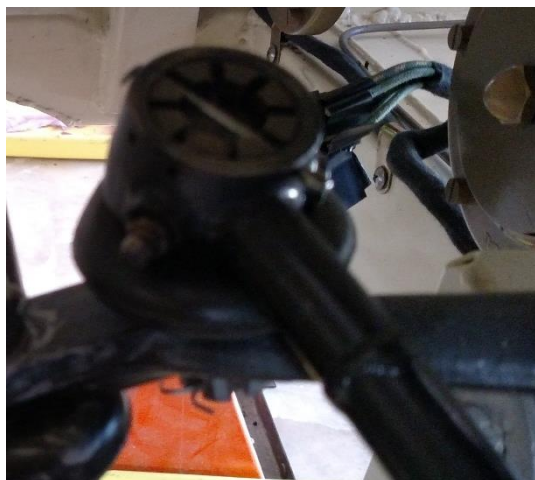
Chassis no. 157624 Jun '54 – Steering cross and side tubes changed to non-adjustable ball pins versus the adjustable pins of earlier cars.

Early adjustable ball pins. No. 724

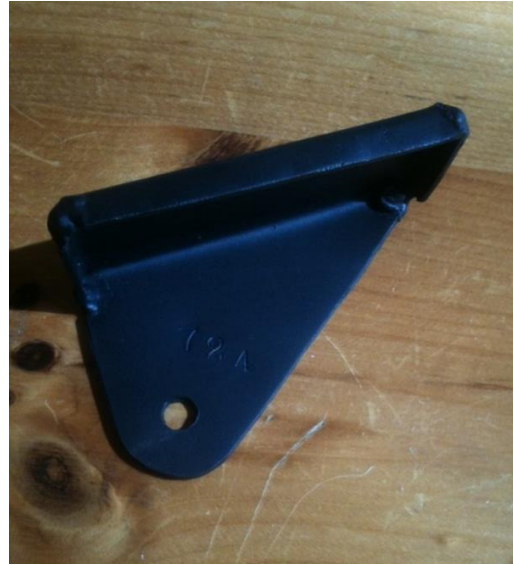
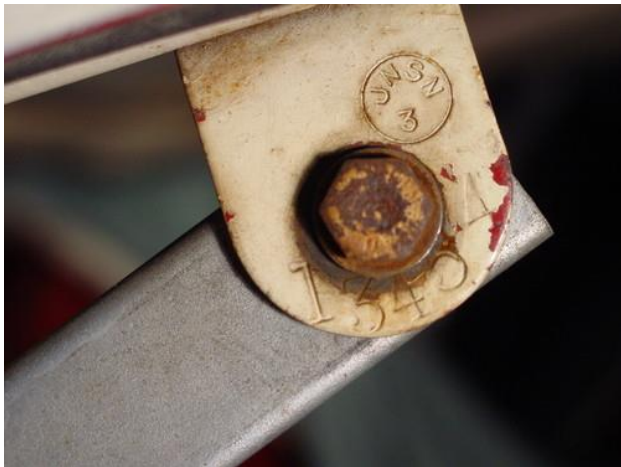
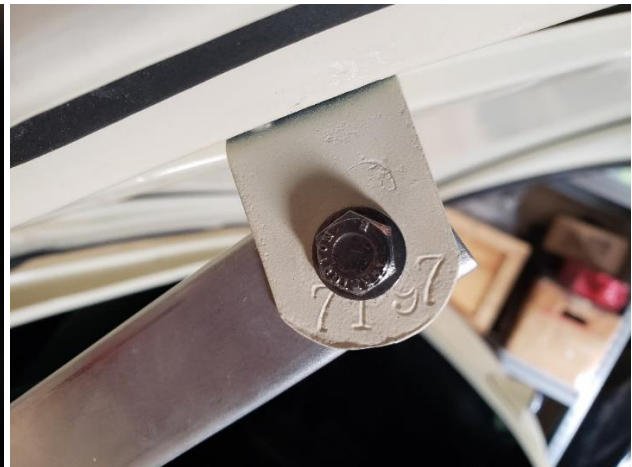
Body no. 4129 (c158100) Jun '54 – Boot changed from aluminum to steel. [With this change, the boot lid prop rod tab changed in design.](#)

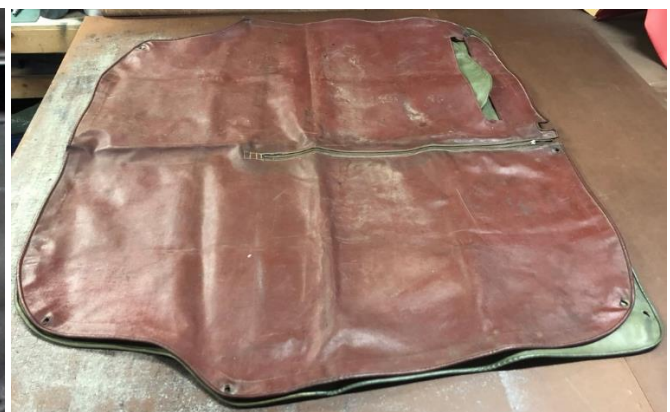
Early narrow cover over later wider tonneau.

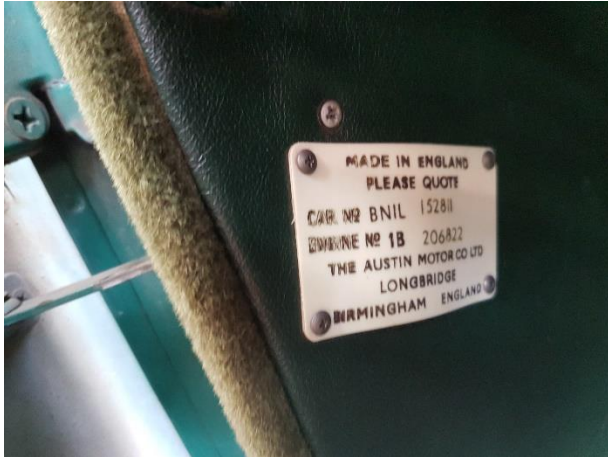
Chassis no. 219001 Sep '54 – First car with unified chassis/engine number, and the preceding series of engines used in AH 100s appears to have ended in the range of 216XXX. *This appears to be the point where the plastic chassis and engine no. tag on the foot well trim panel was changed to the oval aluminum unified chassis/engine no. tag. Also, at this point the aluminum chassis tag was removed from the right frame rail in the engine compartment by the master cylinder bracket, however the two mounting holes for this tag remained through the end of BN2 production. This new oval aluminum tag remained in the driver's foot well at least until early Jan. '55, when it was moved to the firewall below the batch/body number tag.*

Plastic chassis & engine no tag in foot well.

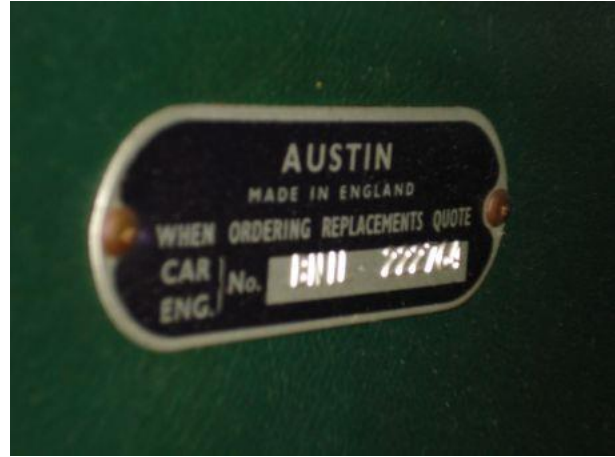
Oval metal (aluminum) chassis tag in foot well.

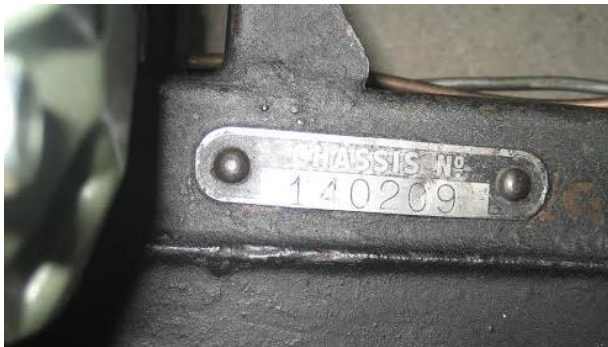
Chassis tag riveted to right frame rail.

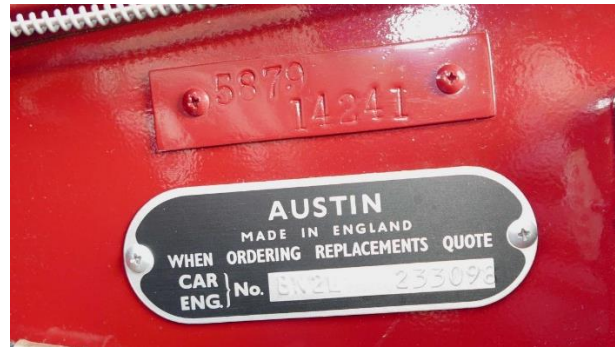
Oval metal (aluminum) chassis tag moved to firewall, underneath the batch/body tag.

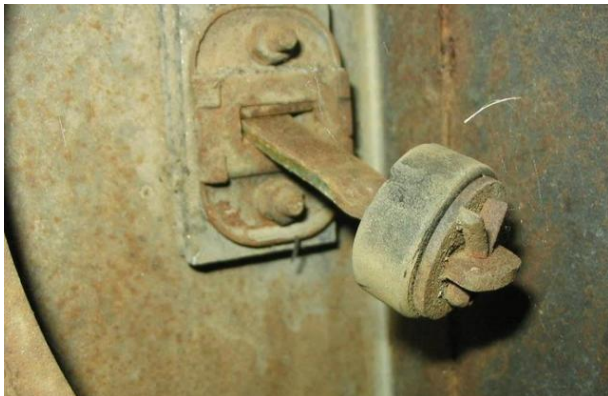
Body no. 5100 (c219046) Sep '54 – Aluminum door hinges changed to steel. Improved check straps.

Original assembly from a very early BN1.

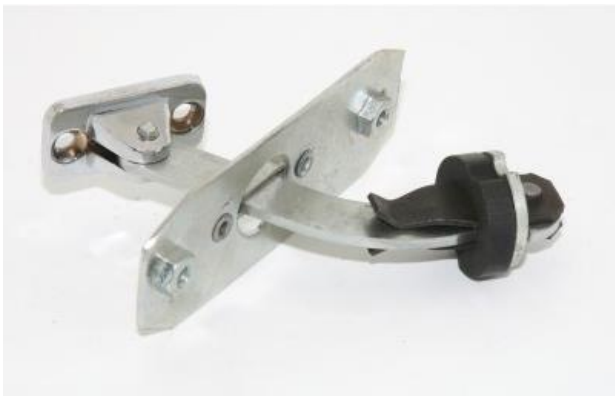
Moss Motors current offering of the later assembly.

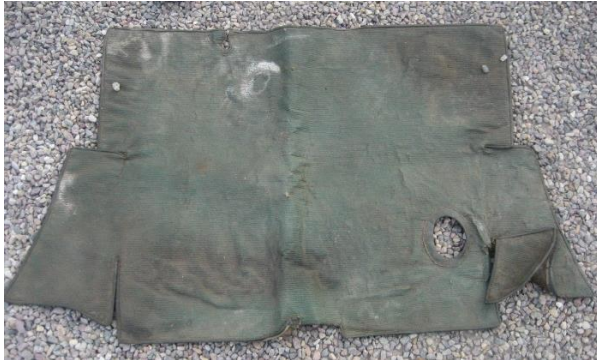
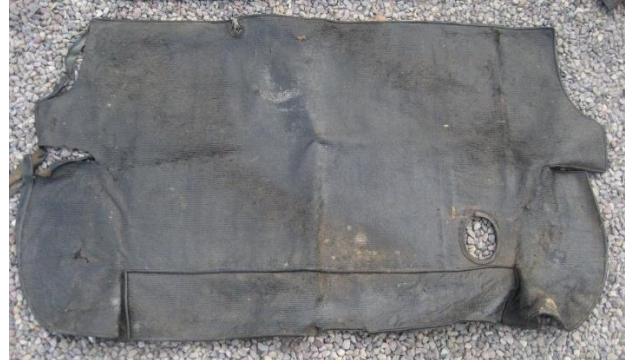
Early... no. 6046 (yes, this does not confirm to the changeover point! Nothing is absolute.)

Late... no. 7197

Body no. 6128 (c221310) Sep '54 - Rear reflectors on pods fitted (NY Auto Show Car). *Early reflector pods were sand cast brass, car 6182 had brass pods and at least one car as late as body no. 7197 Jan. '55. However, pot metal pods have been found on cars as early as 6973. Further documentation is needed.*

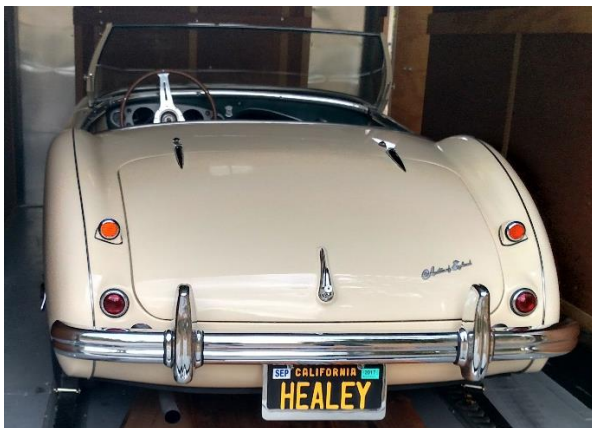
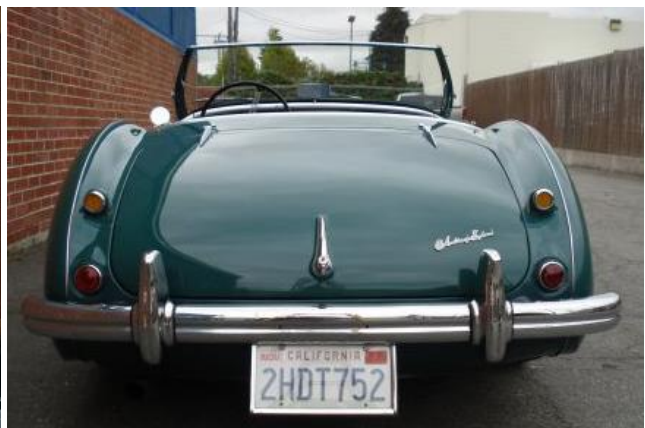
c222664, body no. 7197 built Jan. 11, '55.

c222764, body no. and build date unknown. Unrestored car.

Reflector pods w/ Austin of England boot badge. Note original orange reflexes.

Body no. 7200? (c222800?) Jan '55 – Boot lid emblem "Austin of England" changed to "Austin-Healey". *There is definitely some debate on this issue, with some documents stating (Clausager) that the Austin Healey badge was introduced with the addition of the rear reflector pods. However, this appears to be incorrect as cars with chassis nos. 221342, 222333, 222344, 222529, 222664 and 222764 all built in Dec '54 and Jan. '55 had both reflector pods and the Austin of England boot badge. Both 222344 and 222764 (pictured below) are essentially unrestored and well documented cars with 18-20K original miles.*

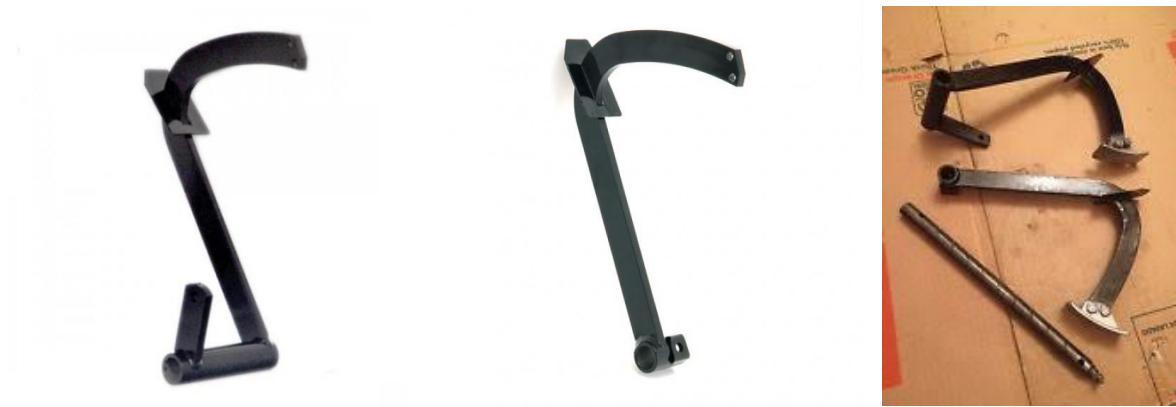
BN1 original brake and clutch pedals. Note how they are "butt" welded to the shaft.

Chassis no. 222781 Dec '54/Jan '55 – Brake pedal lever strengthened.

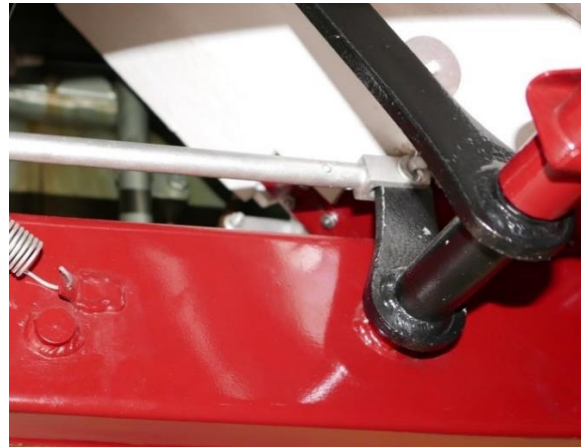
BN1/2-Brake pedal strengthened.

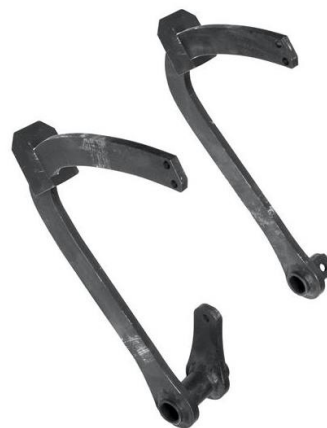
These are reproductions, note the strengthened clutch pedal, which I don't believe is original.

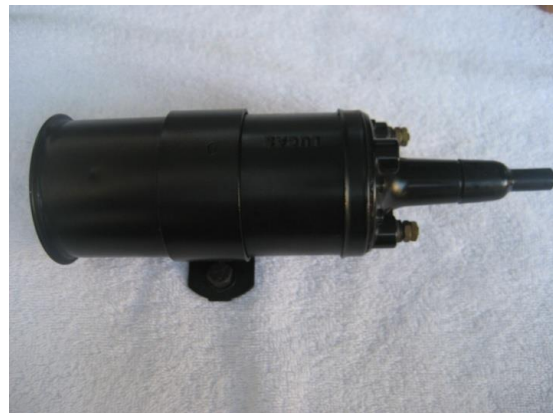
Original BN1 coil, model B12, part no. 45012A/D.

Chassis no. 225780 May '55– Oil filled aluminum ignition coil replaced the original black steel B12/1

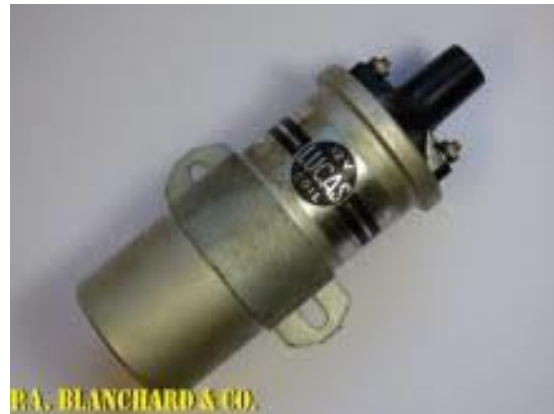
Lucas late BN1, BN2 coil, model HA 12, part no. 45054D/E.

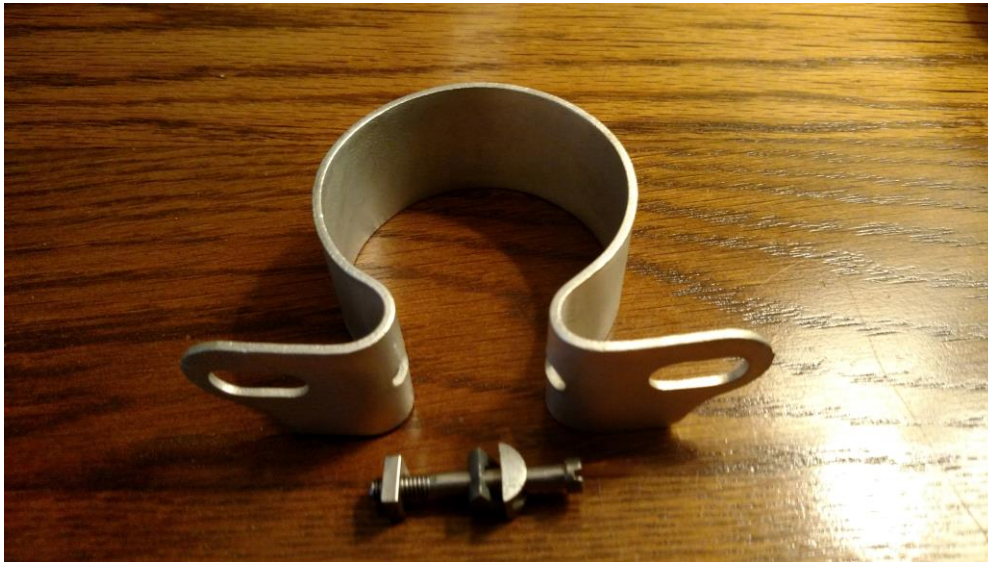
The BN2/100M coil brackets were very unique and looked like this photo above.

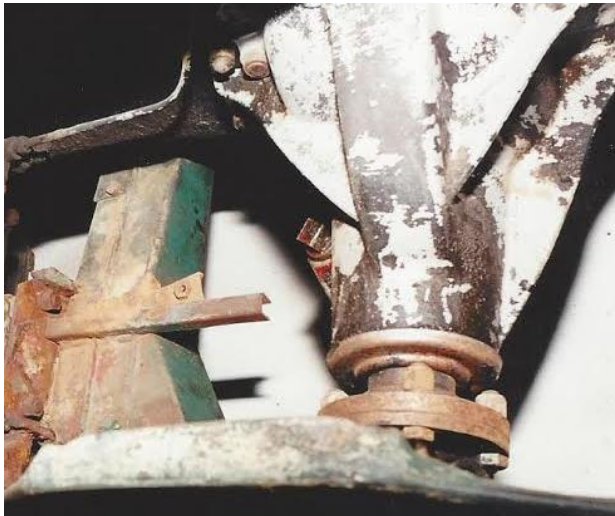
BN1 Hypoid Bevel rear axle filler pug on carrier.
Note original red paint remnants on plug.

Chassis no. 228012 Aug. '55 – Oil filler plug moved from differential carrier to the rear of the axle casing.

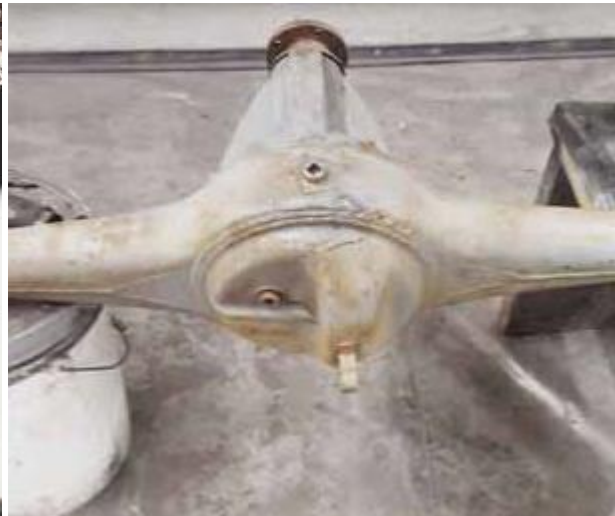
BN2 Hypoid Bevel rear axle filler pug on top of axle casing.

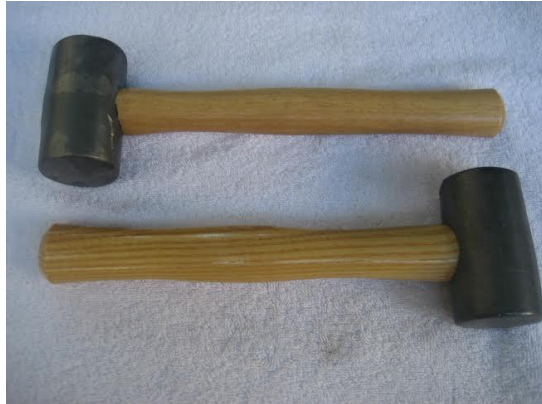
Accurate reproductions of the BN1/early BN2 lead knockoff hammer.

Chassis no. 229654 Nov '55 – Lead hammer in tool kit replaced by Copper hammer.

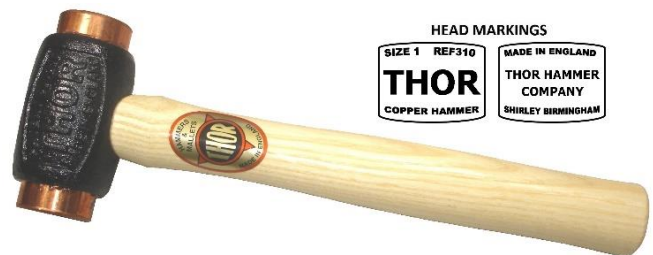
Thor Size 1 copper/copper hammer.

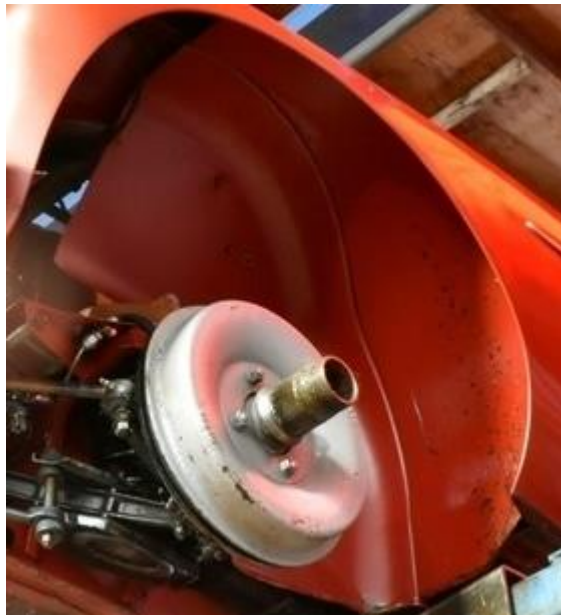
BN2 no. 13340 w/out front inner fender stiffening ridges.

Body no. XXXXX (c2XXXXX) Nov '55 – Stiffening ridges on front inner fenders eliminated?

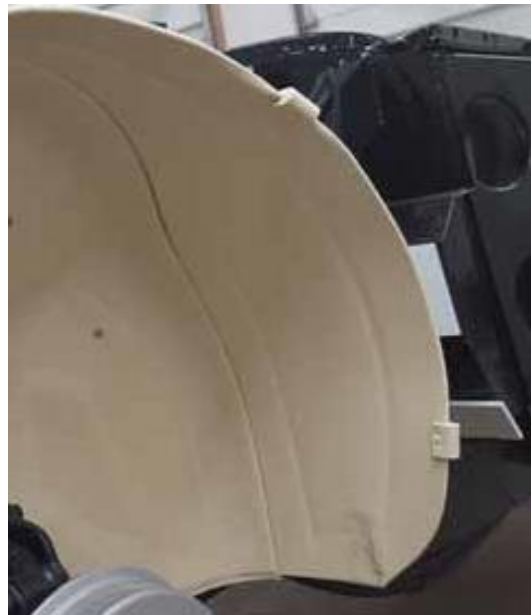
BN1 no. 7197 with stiffening ridges.

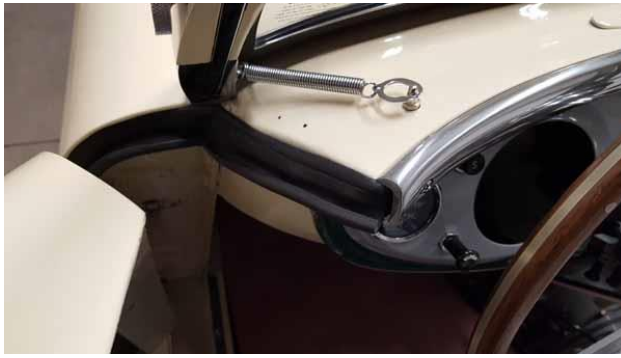
NOS improved scuttle seal installed. There was a BMC Service Bulletin on the modification.

Body no. 11143 (c229180) Nov '55 – Improved rubber seal between door and scuttle to prevent water entering at this point.

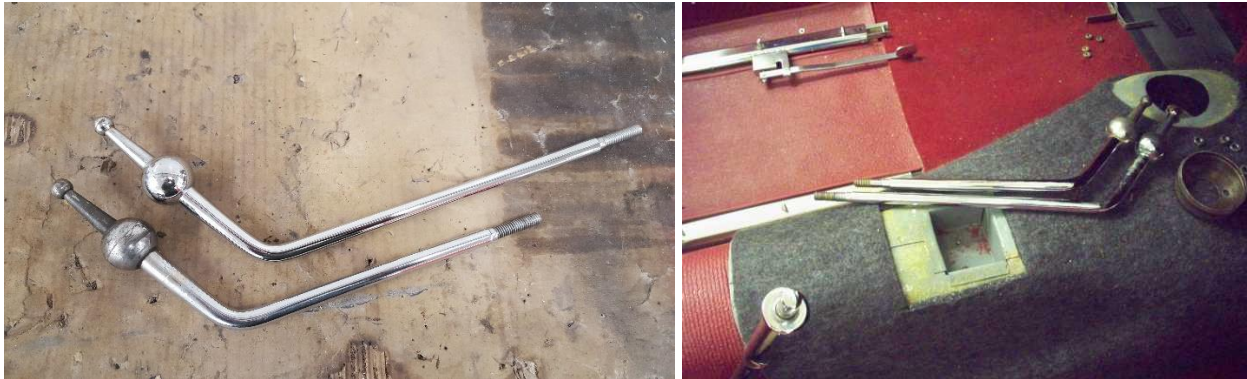
Chassis no. 231968 Apr. '56 – As per the 100 Parts List, an alternate Change Speed Lever (shift lever) was introduced at C.E. 231968. The alternate was approximately 2.5 inches shorter than the lever used prior to that, however several examples of original BN2s with earlier C.E. numbers having the shorter lever have been documented. The earliest examples of original installations of the shorter lever date from early Feb 1956.
