Fig. M.2. Rear brake backplate exploded.

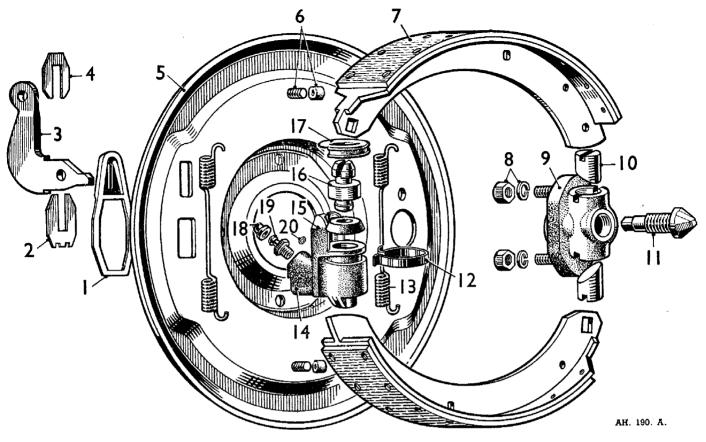
- 1. Rubber seal.
- 2. Wheel cylinder locking plate.
- 3. Handbrake lever.
- 4. Wheel cylinder locking plate.
- 5. Backplate.
- 6. Steady post.
- 7. Brake shoe.

- 8. Nut and spring washer.
- 9. Adjuster body.
- 10. Adjuster tappets.
- 11. Adjuster wedge.
- 12. Dust cover clip.
 13. Shoe return spring.
- 14. Pipe orifice.

- 15. Cylinder body.
- 16. Piston.
- 17. Dust cover.
- 18. Bleed nipple dust cover.
- 19. Bleed nipple.
- 20. Bleed valve ball.

Adjustment for lining wear is made by the brake shoe adjuster. This has a steel housing which is spigotted and bolted firmly to the inside of the backplate. The housing carries two opposed steel links, the outer end slotted to carry the shoes, and the inclined inner faces bearing on inclined faces of the hardened steel wedge.

The wedge has a threaded spindle with a square end which projects on the outside of the backplate, enabling a spanner to be used for adjustment purposes, by rotating the wedge in a clockwise direction, the links are forced apart and the fulcrum of the brake shoes expanded.

When the brake is applied, the piston under the influence of the hydraulic pressure, moves the leading shoe and the body reacts by sliding on the backplate to operate the trailing shoe.

The handbrake lever is pivoted in the cylinder body, and when operated the lever tip expands the leading shoe,

and the pivot moves the cylinder body and with it the trailing shoe.
