Austin Healey BN1/2 Quick Reference Concours Chart of Production Changes by Chassis, Engine and Body Numbers *(Compiled by Curt Arndt - 09/17/2020)* **INITIAL DRAFT**

This list denotes changes listed by either chassis, engine, body number and approximate date. *This chart is designed as a quick reference guide with photos to help the owner and others identify the various changes throughout 100 production. These are just some of the more obvious or visible changes, and are typical of the questions owners ask about their cars. A more detailed and complete list can be found in the Concours Guidelines and other publications such as the Clausager book.*

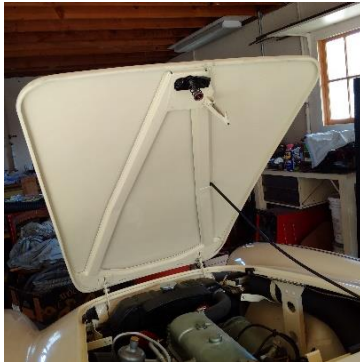
Body no. 724 (c1496XX) Nov '53 to body no. 877 (c149XXX) Nov./Dec. '53 – Sometime during this period, a side to side cross brace was added to the aluminum bonnet frame for strength and stiffening. This brace is a rectangular "U" shaped channel attached to the underside of the "V" brace with four truss head sheet metal screws. The exact changeover body no. is unknown and may be before no. 877.

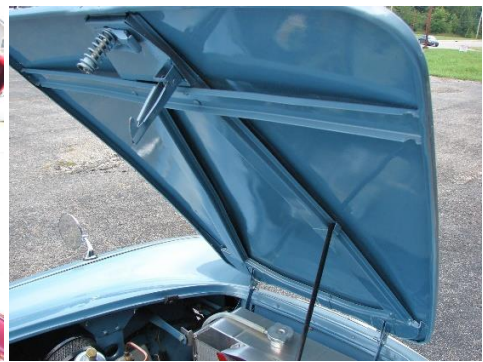
All cars, body no. 877 and after to no. 3396

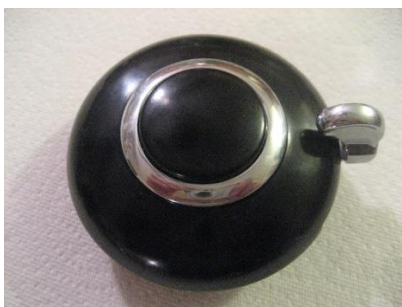
Body no. 1001 (c149930) Dec '53 – Adjustable steering column discontinued, driver's seat now on slides. The smaller hub of the non-adjustable steering wheel necessitated a decrease of the width of the aperture in the fascia (dash). The chromed turn signal lever which denoted an adjustable steering column was replaced with a black "beak" type which denoted a non-adjustable steering column. Austin Service Journal dated 10 May 1954 addresses this change.

BN1 adjustable.

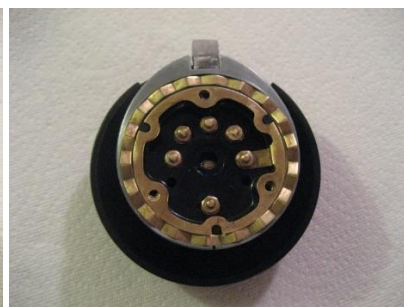
Early adjustable, back side.

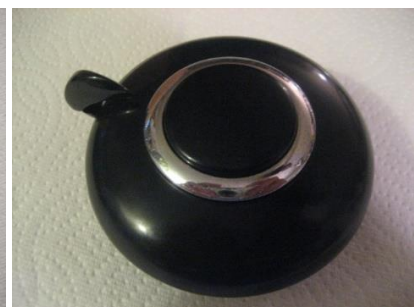
BN1/2 non-adjustable.

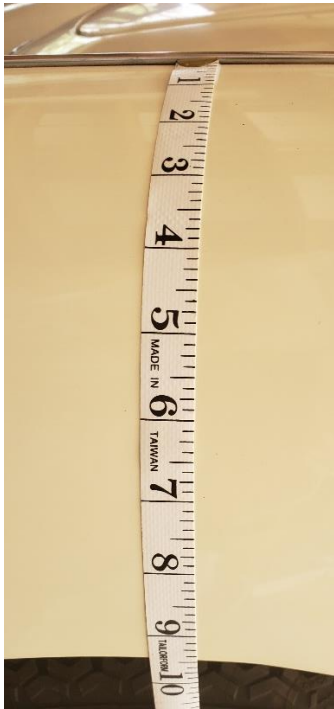
Body no. 1001 (c149930) Dec '53 – Front wings with 3/16" to 1/2" higher wheel cutout. 9" from beading to top of the wheel arch. *Therefore, most early BN1s before body no. 1000 had front wings whose wheel cutout from beading to top of the wheel arch was approximately 9-3/16" to 9-1/2".*

BN1 left wing 9-1/2"
No.724 Nov. '53

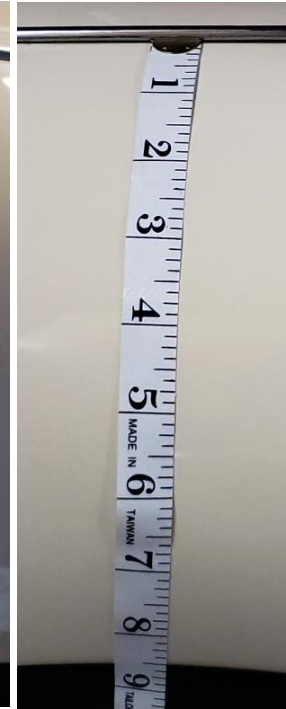
NOS BN1 left wing, 8-1/2"

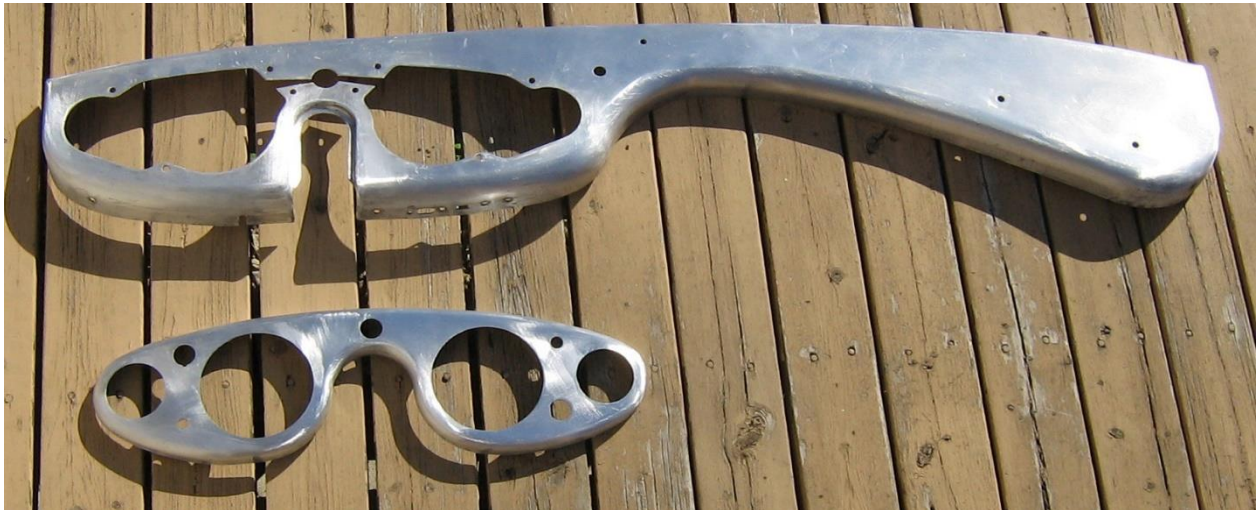
Body no. 1855 (c151795) Feb '54 – Fascia and instrument panel changed from two piece to one piece. Regarding the two piece dash, there were two types and two removable instrument cluster sections.

This type pictured above is the later type for cars with non-adjustable steering. Note the flange extension in the "U" shaped channel for the steering column. This type had the rounded tabs on the back, versus the square tabs.

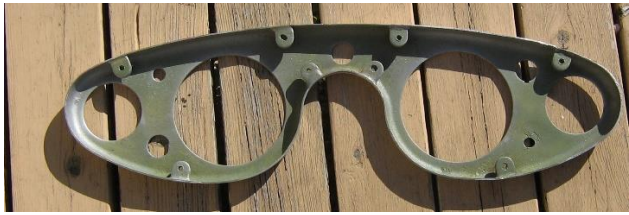
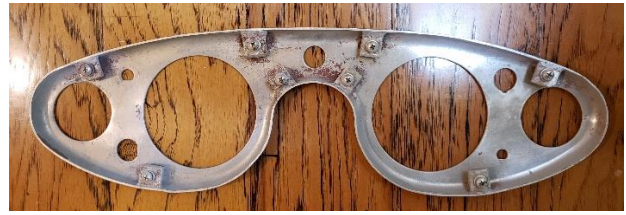
Left- Late non-adjustable cluster w/ rounded tabs Right- Early adjustable cluster w/ square tabs.
Two-piece dash instrument cluster held in by eight, no.2 BA or no. 10-32 Phillips pan head screws (pictured right).

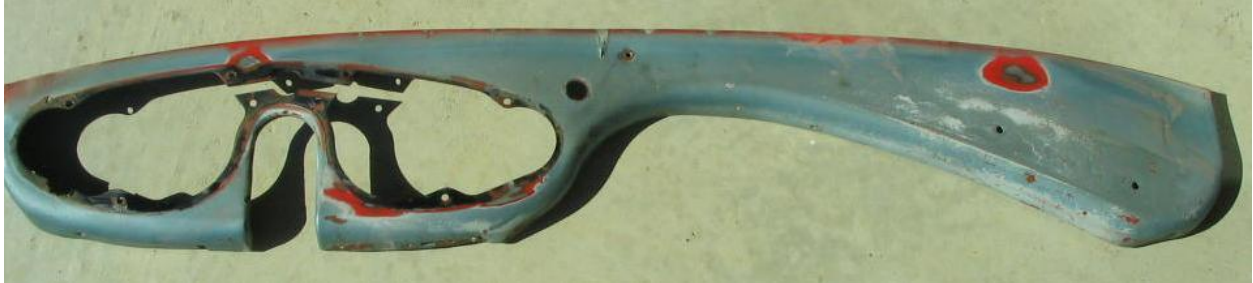
Early adjustable steering dash. Note the lack of the extra flange in the "U" shaped channel. M. Salter Photos.

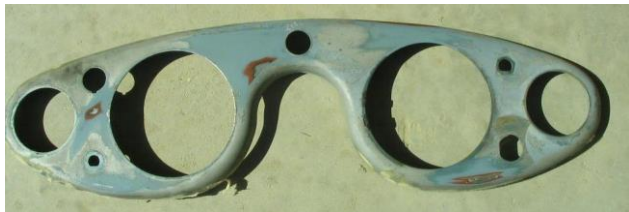
This is the instrument cluster section for the dash above. This would have had the "square" tabs on the back.

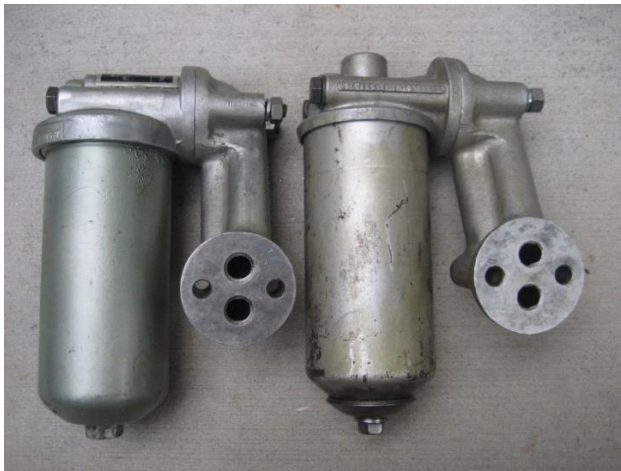
Engine no. 207112 Apr '54 – New type of Tecalemit oil filter introduced. Purolator oil filter not changed, and used throughout BN1/2 production.

Tecalemit Oil filters, early-left versus late-right.

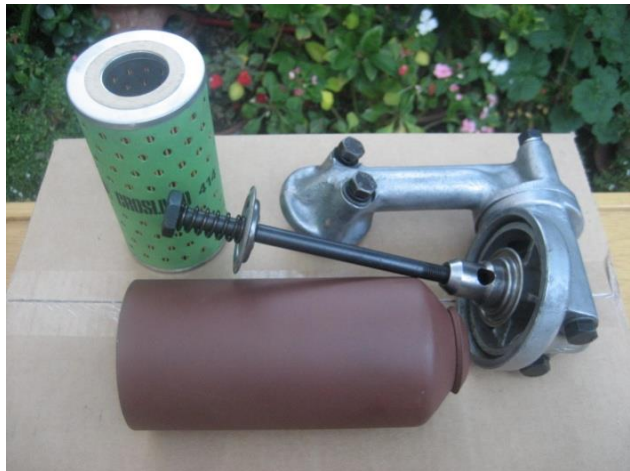
Purolator filter assembly.

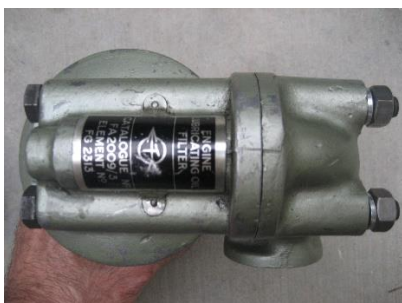
Early Tecalemit

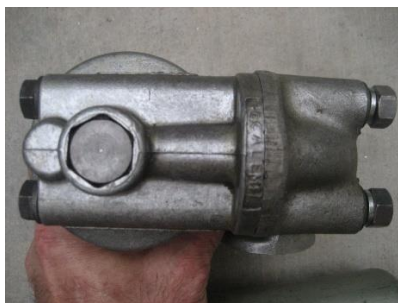
Late Tecalemit.

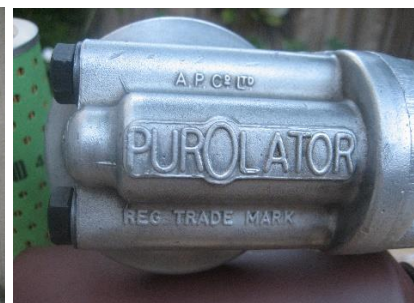
Purolator filter.

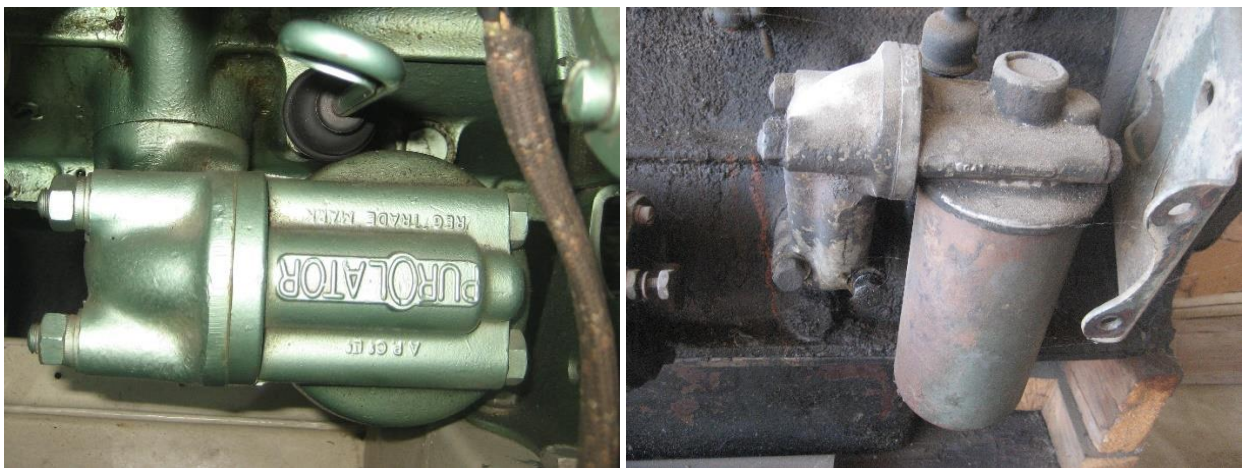
A Purolator and a “late” Tecalemit filter assemblies oriented vertically.

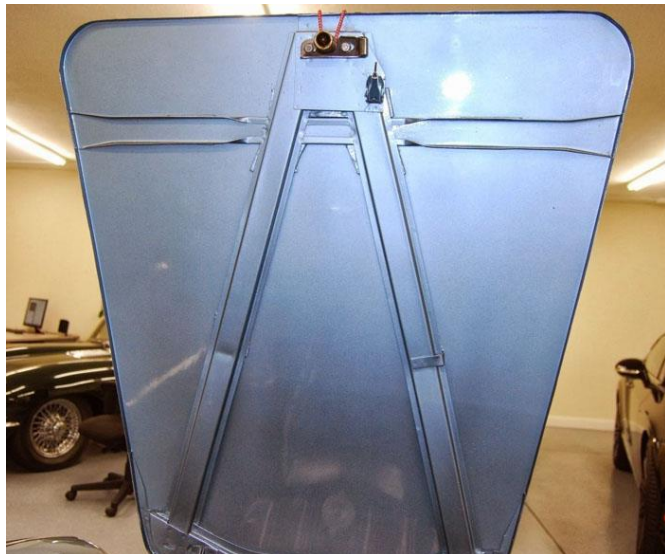
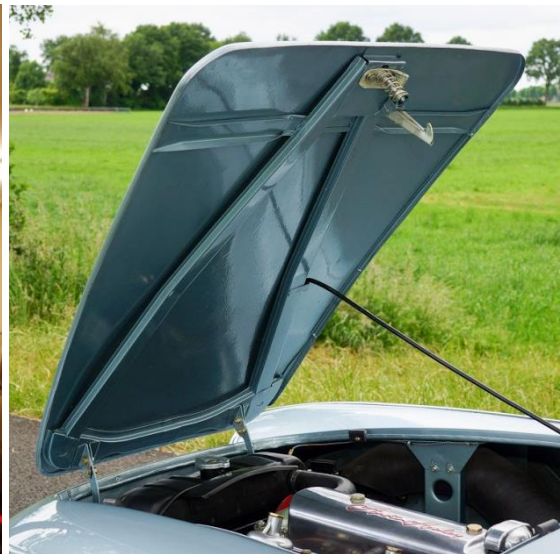
Body no. 3397 (c156120) May '54 – Bonnet changed from aluminum to steel. *It is most likely at this point is where the side to side cross brace was modified; flattened in the center, and now placed between the "V" brace and the bonnet skin.*

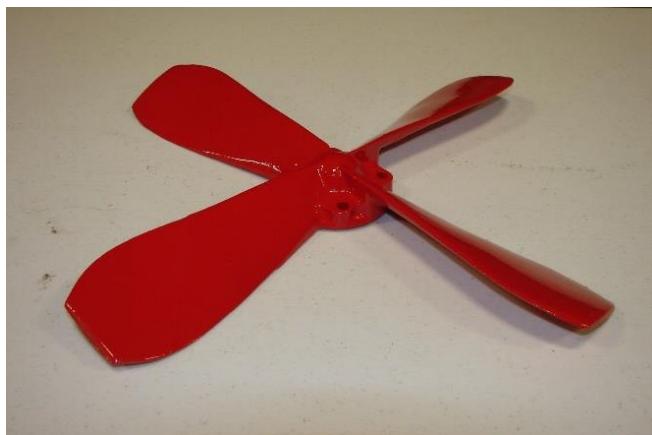
Engine no. XXXXXX Xxx '54 – Engine fan blades changed from having round tips to the more squared off tips. *The latest known/documented car with the rounded fan blades is body no. 3015.*

Square tipped fan, painted in correct "Chinese" Red.

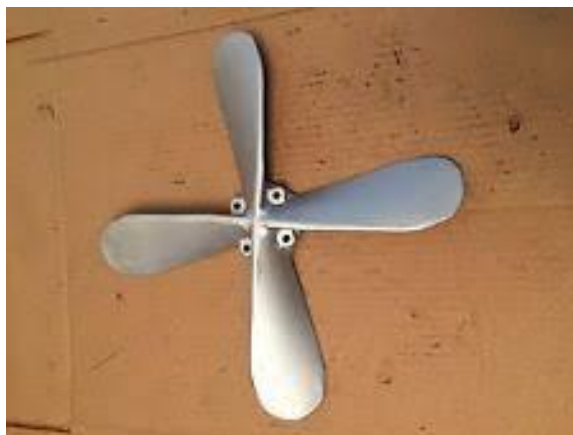
Round tipped fan, unpainted.

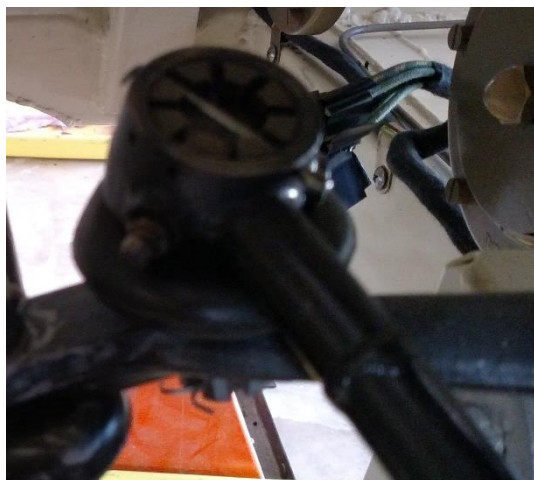
Chassis no. 157624 Jun '54 – Steering cross and side tubes changed to non-adjustable ball pins versus the adjustable pins of earlier cars.

Early adjustable ball pins. No. 724

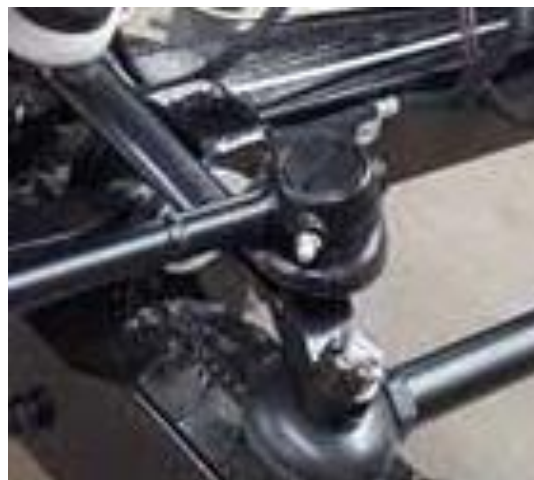
Non-adjustable ball pins. No. 7197.

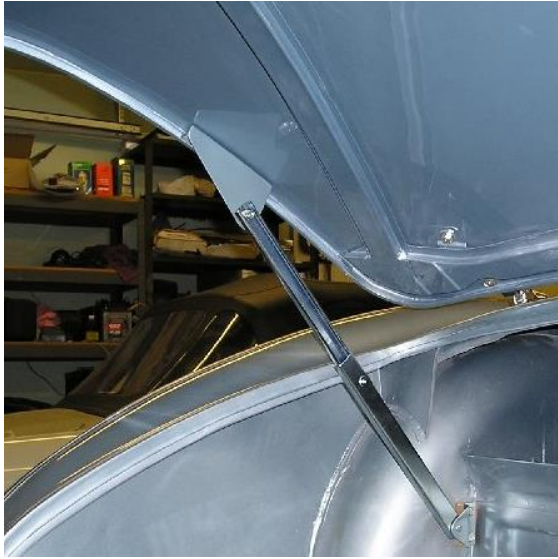
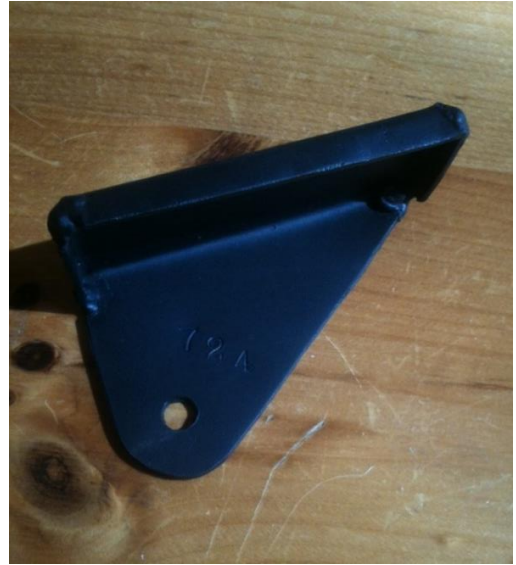
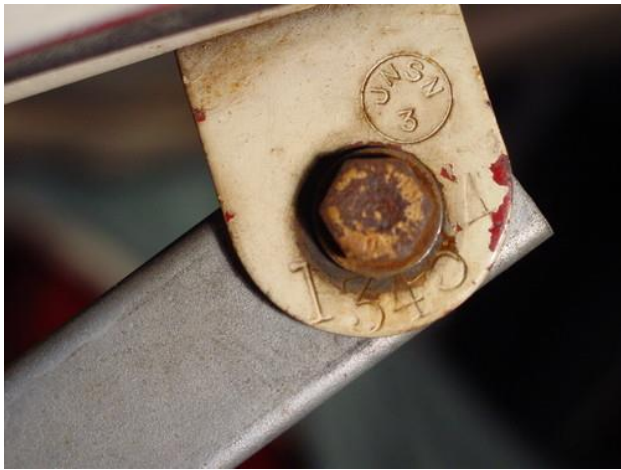
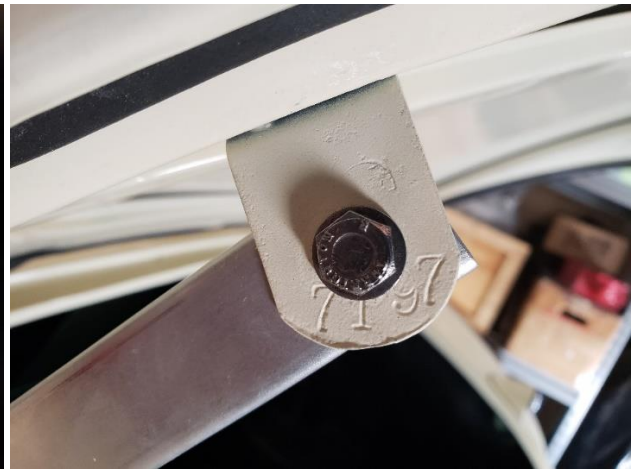
Body no. 4129 (c158100) Jun '54 – Boot changed from aluminum to steel. [With this change, the boot lid prop rod tab changed in design.](#)

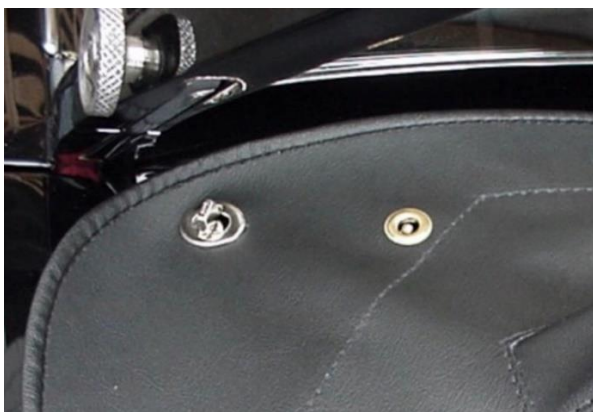
Body no. 4606 (c159339) Jul '54 – Wider tonneau cover with improved fasteners.

Wider BN1, BN2 Tonneau cover w/ turn button and grommet

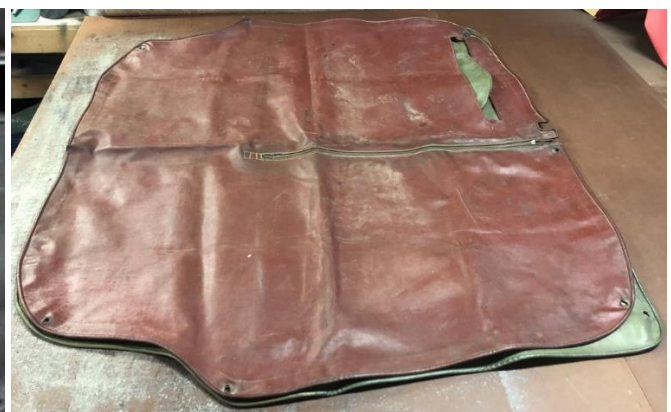
Early narrow cover over later wider tonneau.

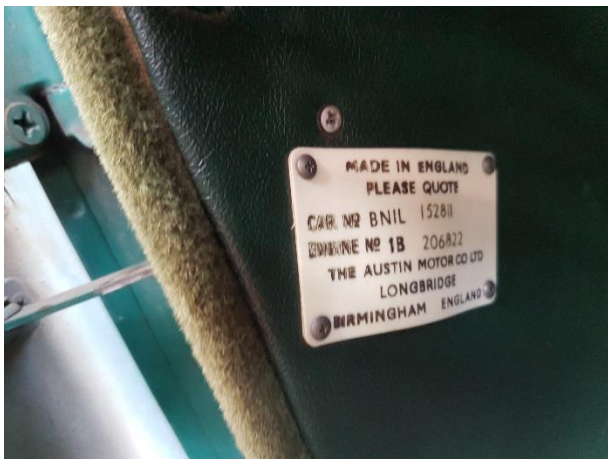
Chassis no. 219001 Sep '54 – First car with unified chassis/engine number, and the preceding series of engines used in AH 100s appears to have ended in the range of 216XXX. *This appears to be the point where the plastic chassis and engine no. tag on the foot well trim panel was changed to the oval aluminum unified chassis/engine no. tag. Also, at this point the aluminum chassis tag was removed from the right frame rail in the engine compartment by the master cylinder bracket, however the two mounting holes for this tag remained through the end of BN2 production. This new oval aluminum tag remained in the driver's foot well at least until early Jan. '55, when it was moved to the firewall below the batch/body number tag.*

Plastic chassis & engine no tag in foot well.

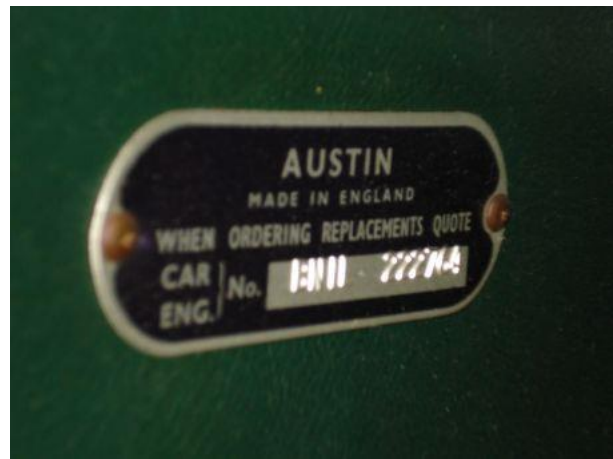
Oval metal (aluminum) chassis tag in foot well.

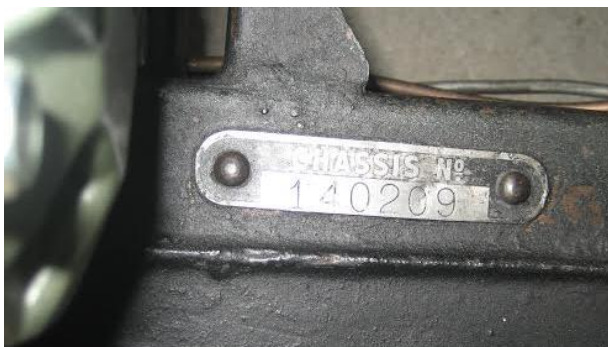
Chassis tag riveted to right frame rail.

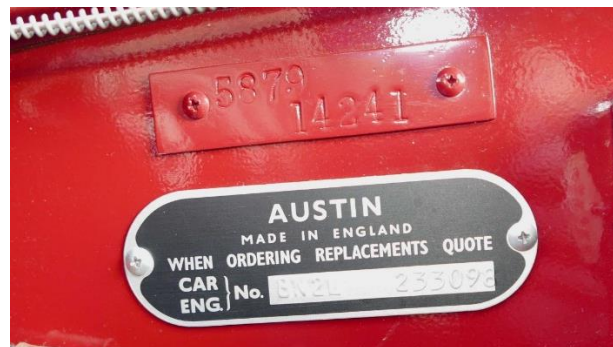
Oval metal (aluminum) chassis tag moved to firewall, underneath the batch/body tag.

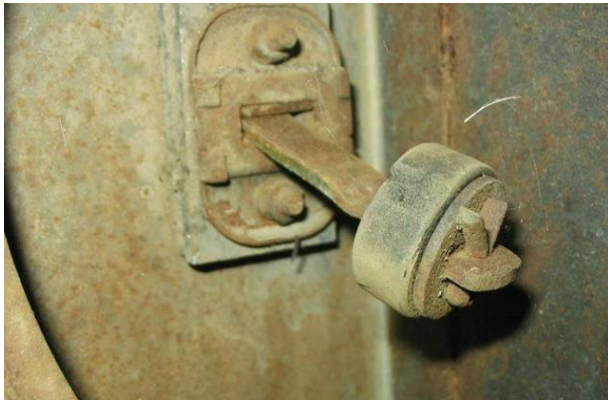
Body no. 5100 (c219046) Sep '54 – Aluminum door hinges changed to steel. Improved check straps.

Original assembly from a very early BN1.

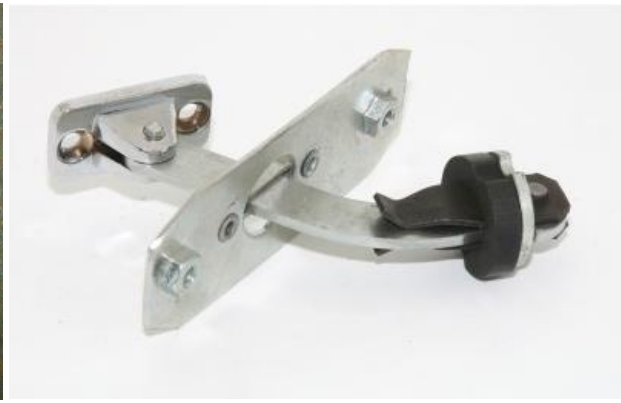
Moss Motors current offering of the later assembly.

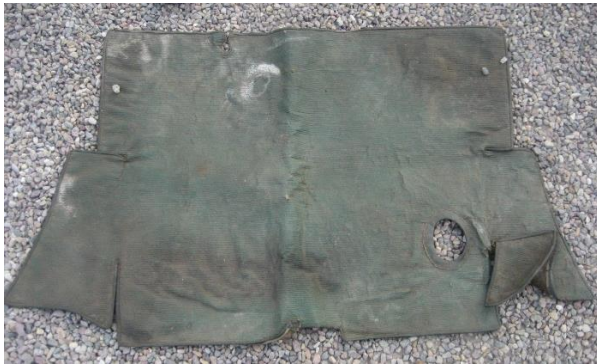
Body no. 5639 Sep '54 – Improved boot floor mat.

Early... no. 6046 (yes, this does not confirm to the changeover point! Nothing is absolute.)

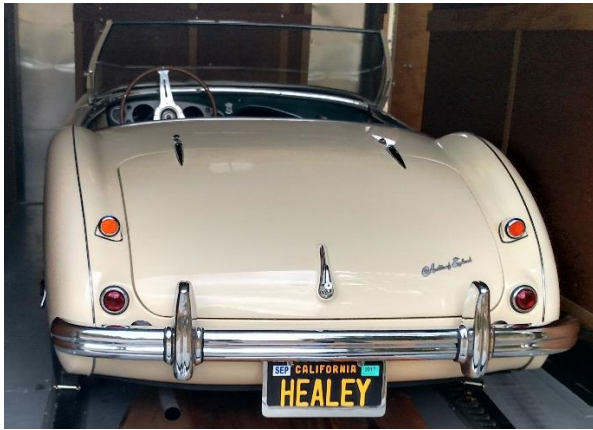
*c222664, body no. 7197 built Jan. 11, '55.
Reflector pods w/ Austin of England boot badge. Note original orange reflexes.*

Body no. 7200? (c222800?) Jan '55 – Boot lid emblem "Austin of England" changed to "Austin-Healey". *There is definitely some debate on this issue, with some documents stating (Clausager) that the Austin Healey badge was introduced with the addition of the rear reflector pods. However, this appears to be incorrect as cars with chassis nos. 221342, 222333, 222344, 222529, 222664 and 222764 all built in Dec '54 and Jan. '55 had both reflector pods and the Austin of England boot badge. Both 222664 and 222764 (pictured below) are the same with 222764 unrestored and well documented with 18K original miles.*

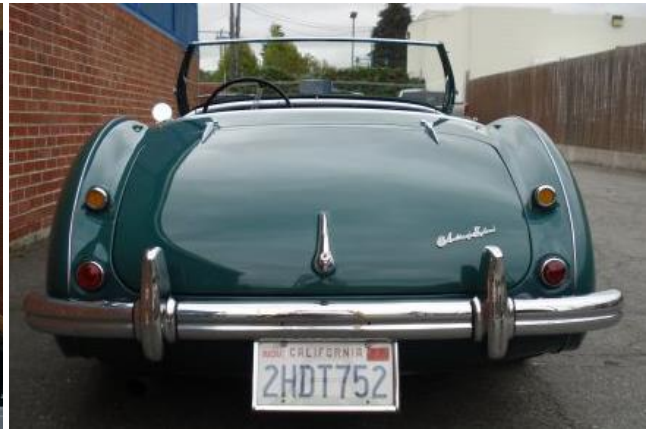
c222764, body no. and build date unknown. Unrestored car.

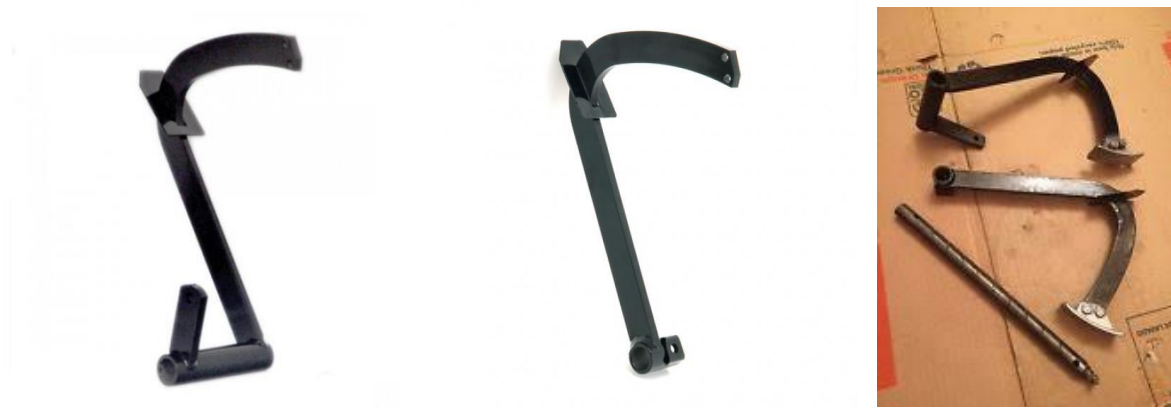
BN1 original brake and clutch pedals. Note how they are "butt" welded to the shaft.

Chassis no. 222781 Dec '54/Jan '55 – Brake pedal lever strengthened.

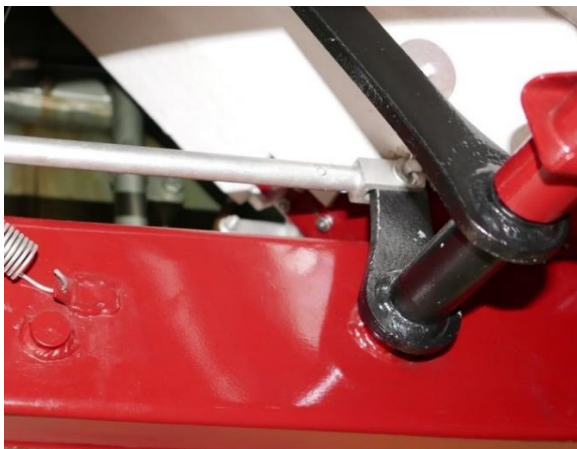
BN1/2-Brake pedal strengthened.

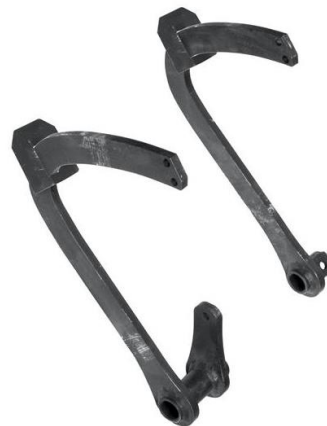
These are reproductions, note the strengthened clutch pedal, which I don't believe is original.

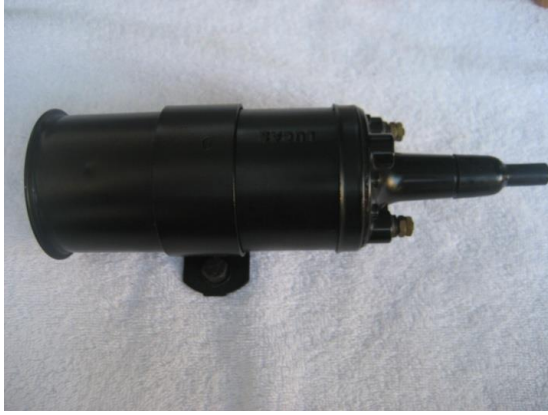
Original BN1 coil, model B12, part no. 45012A/D.

Chassis no. 225780 May '55– Oil filled aluminum ignition coil replaced the original black steel B12/1

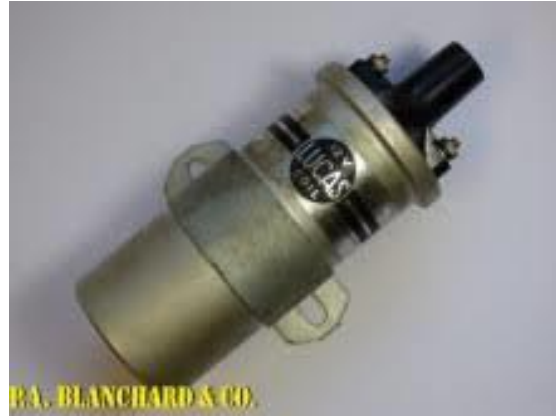
Lucas late BN1, BN2 coil, model HA 12, part no. 45054D/E.

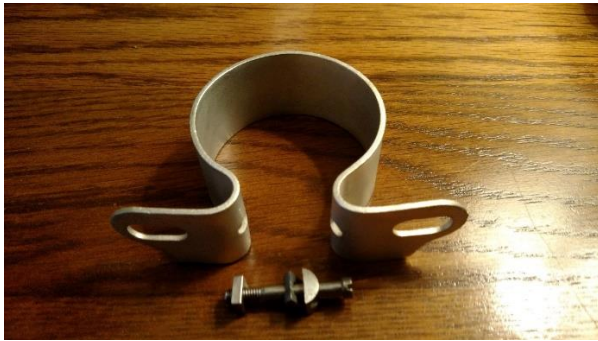
The BN2/100M coil brackets were very unique and looked like this photo above.

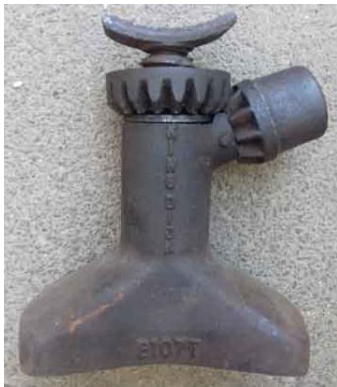
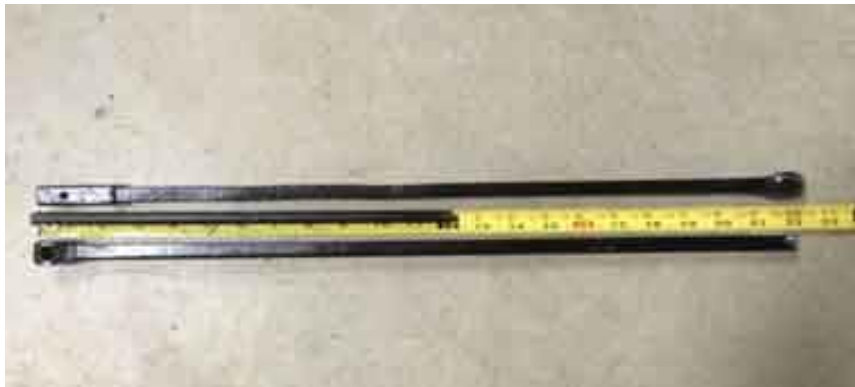
Chassis no. 227339 Jul '55 – New type of lifting jack. King Dick B. 1077 (not dated).

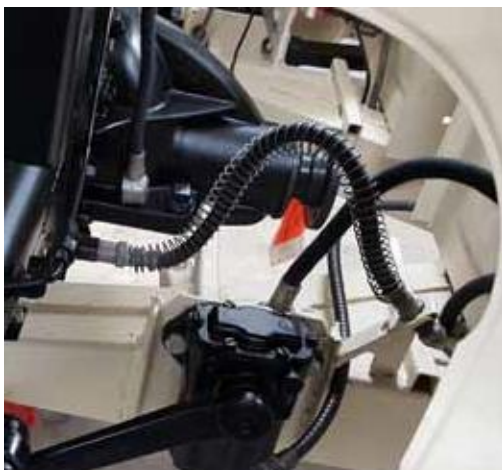
Chassis no. 227560 Jul '55 – The rear flexible brake hose was enclosed in spring steel armour to prevent chaffing.

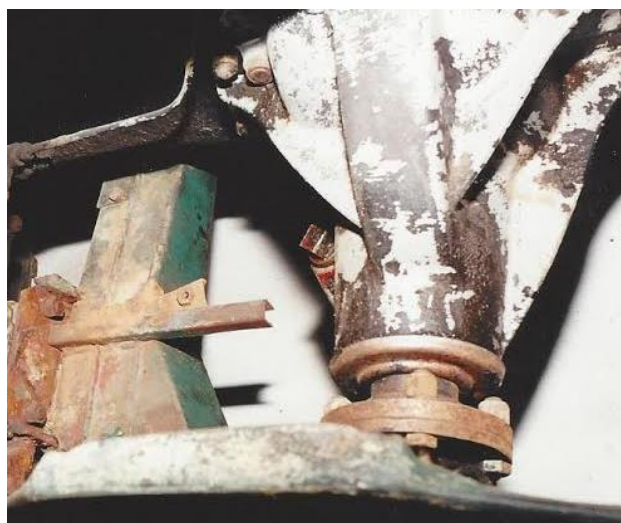
BN1 Hypoid Bevel rear axle filler pug on carrier.
Note original red paint remnants on plug.

Chassis no. 228012 Aug. '55 – Oil filler plug moved from differential carrier to the rear of the axle casing.

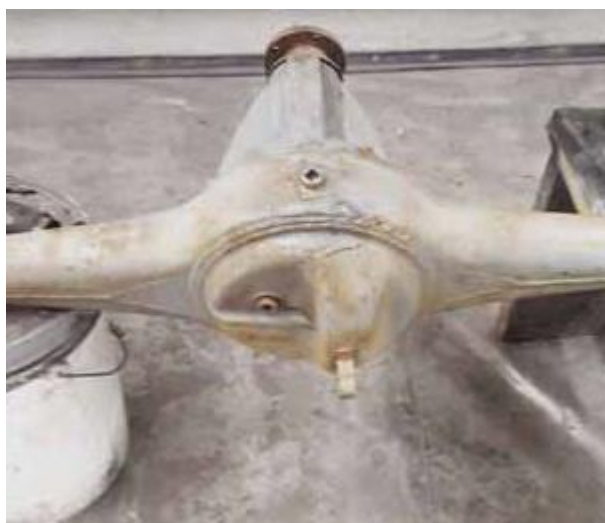
BN2 Hypoid Bevel rear axle filler pug on top of axle casing.

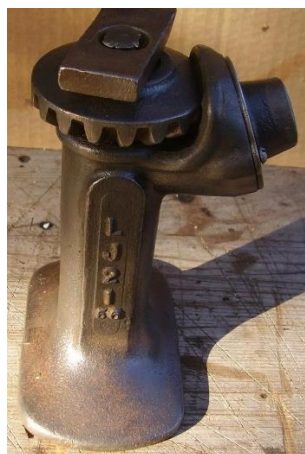
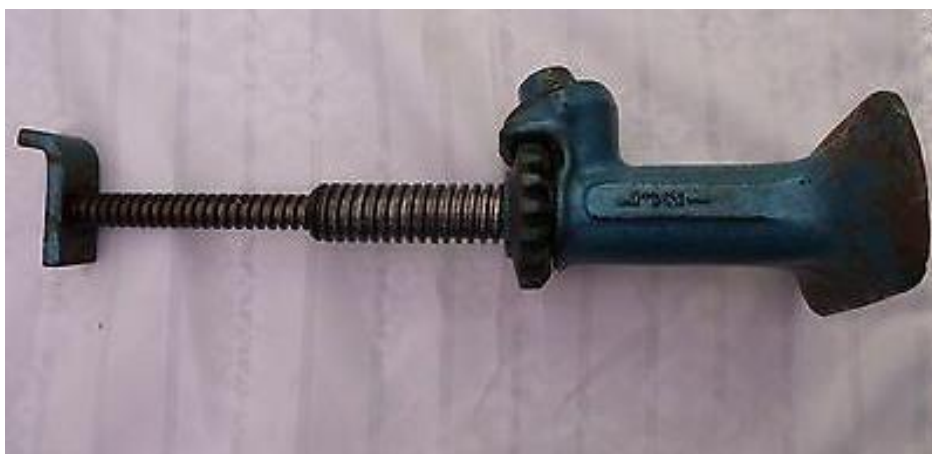
Chassis no. 229080 Oct '55 – New type of lifting jack. Shelley LJ 21 (dated with year, '55 or '56).

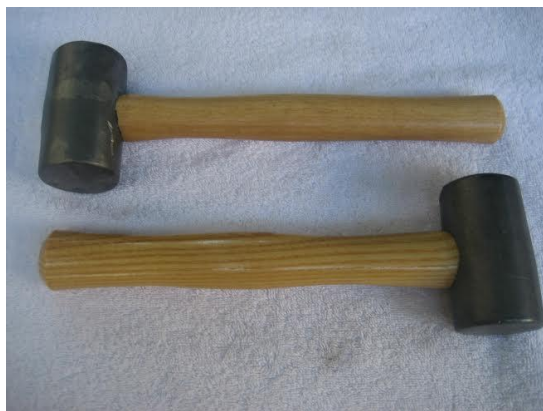
Accurate reproductions of the BN1/early BN2 lead knockoff hammer.

Chassis no. 229654 Nov '55 – Lead hammer in tool kit replaced by Copper hammer.

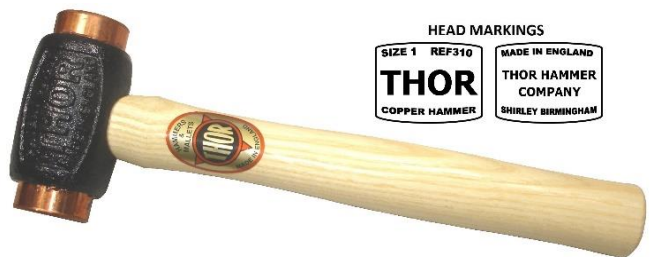
Thor Size 1 copper/copper hammer.

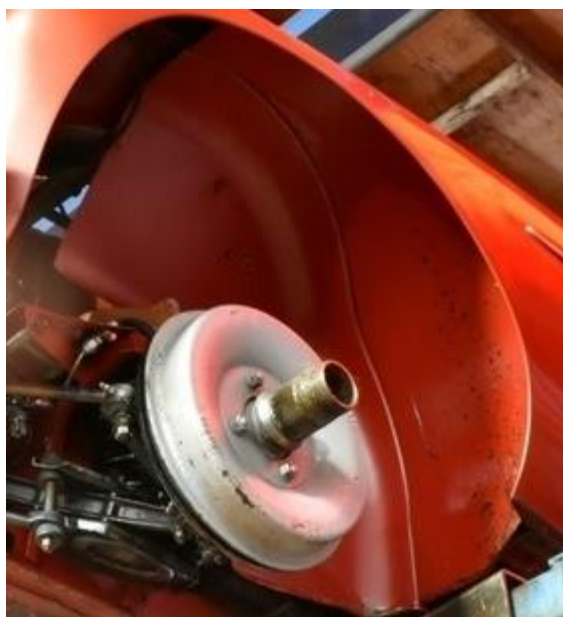
BN2 no. 13340 w/out front inner fender stiffening ridges.

Body no. XXXXX (c2XXXXX) Oct/Nov '55 – Stiffening ridges on front inner fenders eliminated?

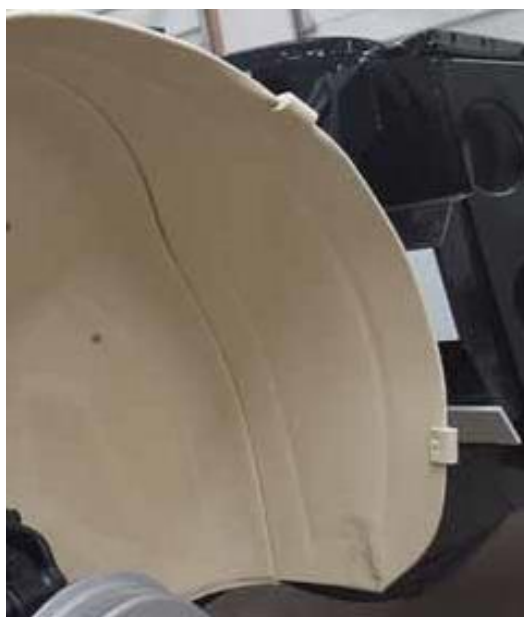
BN1 no. 7197 with stiffening ridges.

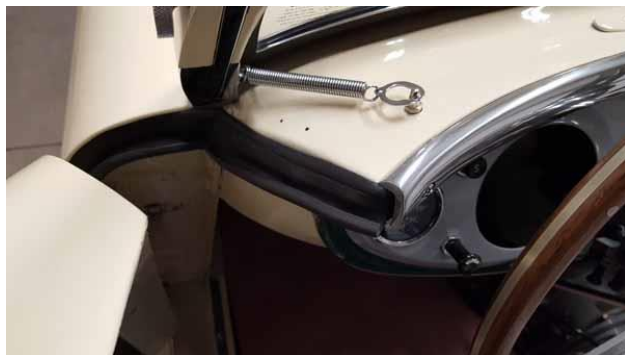
Body no. 11143 (c229180) Nov '55 – Improved rubber seal between door and scuttle to prevent water entering at this point.

NOS improved scuttle seal installed. There was a BMC Service Bulletin on the modification.

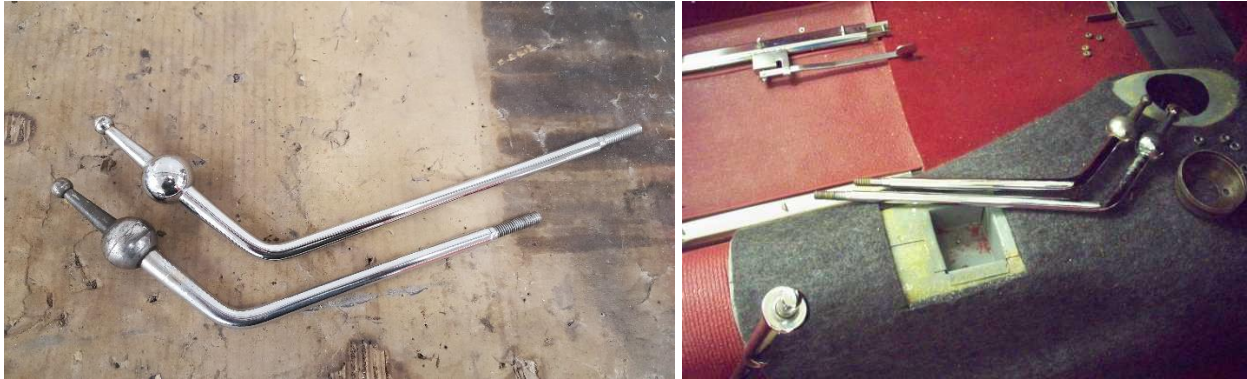
Chassis no. 231968 Apr. '56 – As per the 100 Parts List, an alternate Change Speed Lever (shift lever) was introduced at C.E. 231968. The alternate was approximately 2.5 inches shorter than the lever used prior to that, however several examples of original BN2s with earlier C.E. numbers having the shorter lever have been documented. The earliest examples of original installations of the shorter lever date from early Feb 1956.
